The SPAB RESEARCH REPORT 2.

The SPAB Building Performance Survey 2016

Interim Report

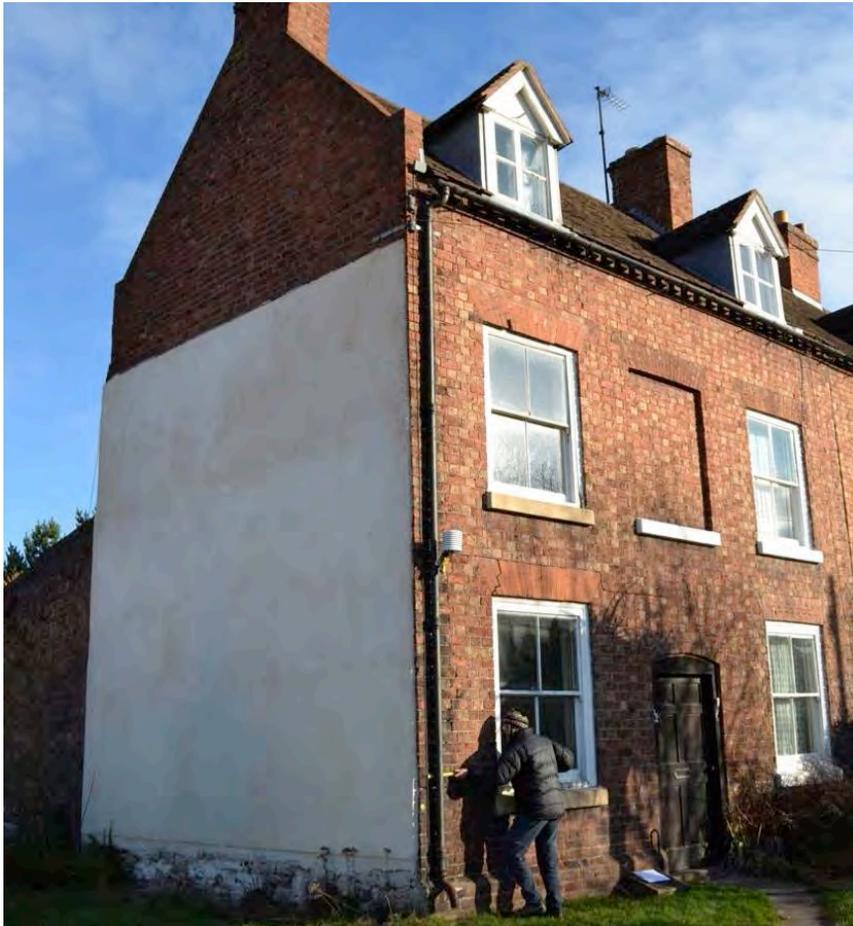
2.1. 116 Abbeyforegate, Shrewsbury - 2015 - 16.

Description: End-of-terrace (originally mid-terrace) house, 2 storeys with attic dormer. Dating from 1820 but with earlier core. Brick with plain-tiled roof, with elements of timber-framing and a modern single-storey extension at rear accommodating a kitchen and bathroom.

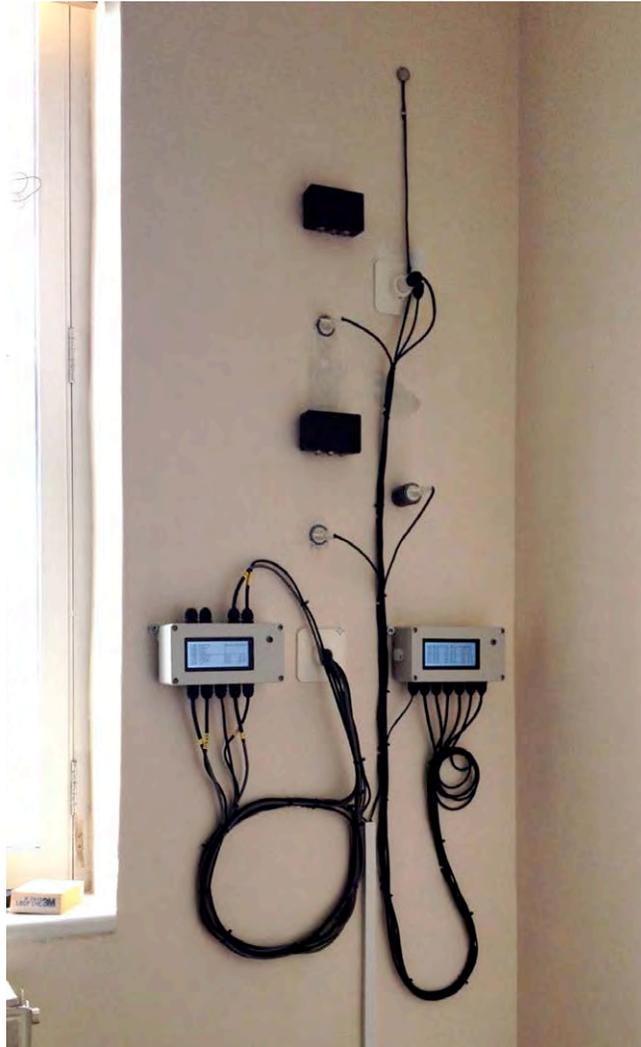
Figure 3. Interstitial Hygrothermal Gradient and Material Moisture Monitoring, Shrewsbury.

Measurements of temperature and relative humidity (%RH) are being made through a section of south-facing brick wall of the living room at Abbeyforegate (Figures 3 and 4). Combined temperature and relative humidity sensors are located at four points within the wall at the heights and depths given in Table 1. This table also gives details of the wall build up before and after insulation (in green).

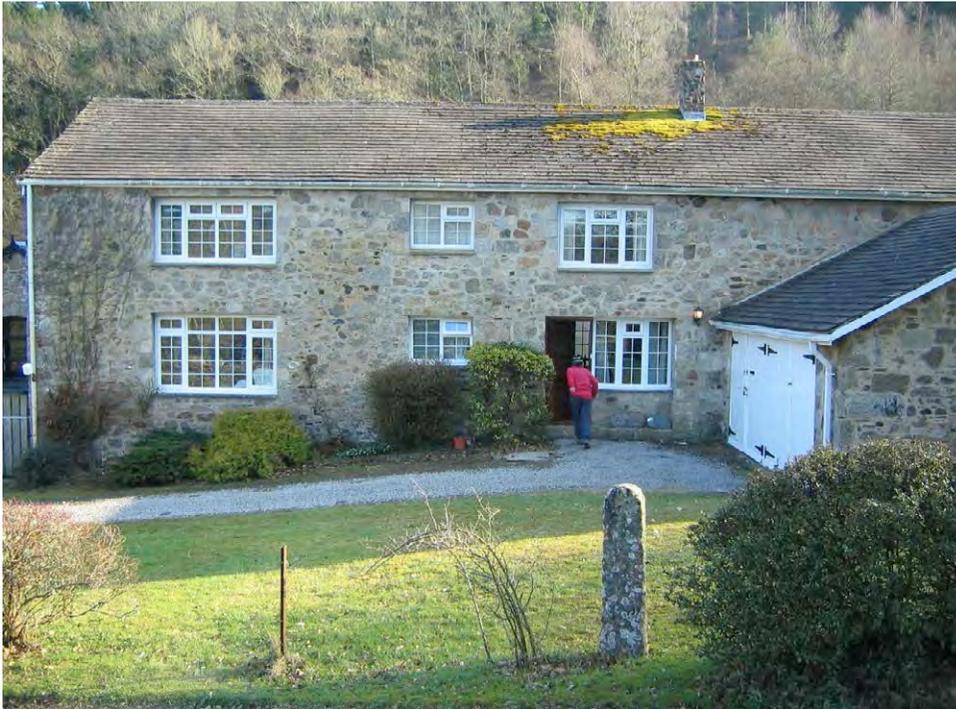
2.2. Mill House, Drewsteignton, Devon - 2015 - 16.

Description: A barn built in granite dating from the nineteenth century or possibly earlier converted to a dwelling in 1970s incorporating a circa 1950's agricultural building at rear.

Refurbishment: The 1950's extension to the rear of the building has been extensively rebuilt as a timber-frame construction, insulated with woodfibre insulation and has new double-glazed timber windows (the windows in the earlier 'barn' section of the house are in PVCu). In 2012, for experimental purposes, a short section of wall in a room in the older barn part of the dwelling, pictured above, was internally

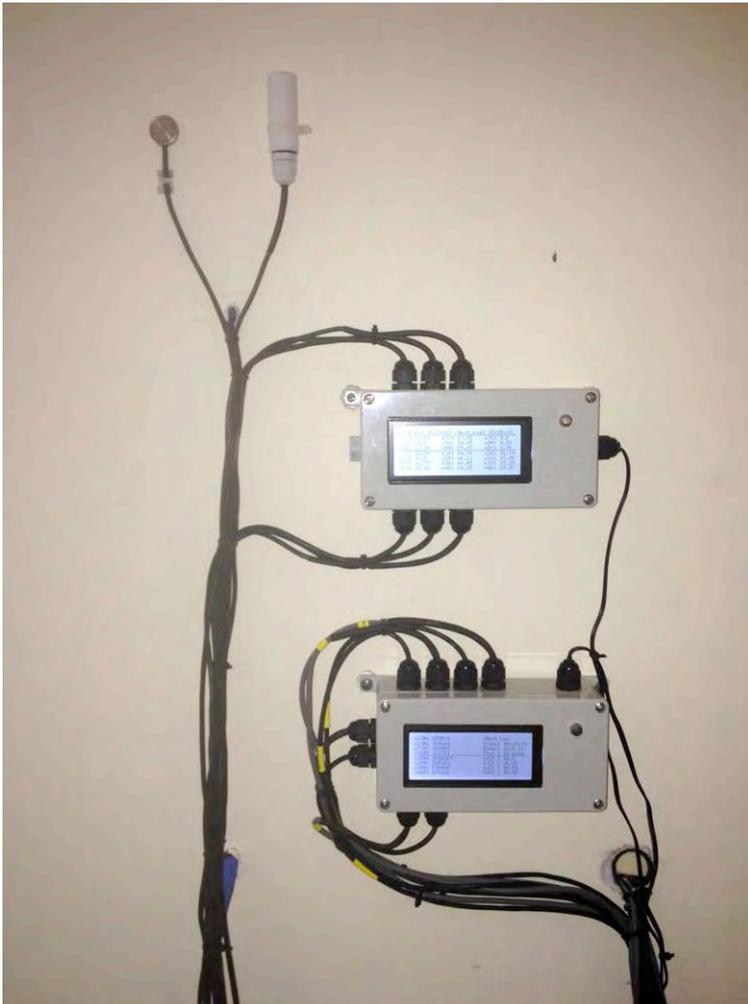
Figure 19. Interstitial Hygrothermal Gradient and Material Moisture Monitoring, Drewsteignton.

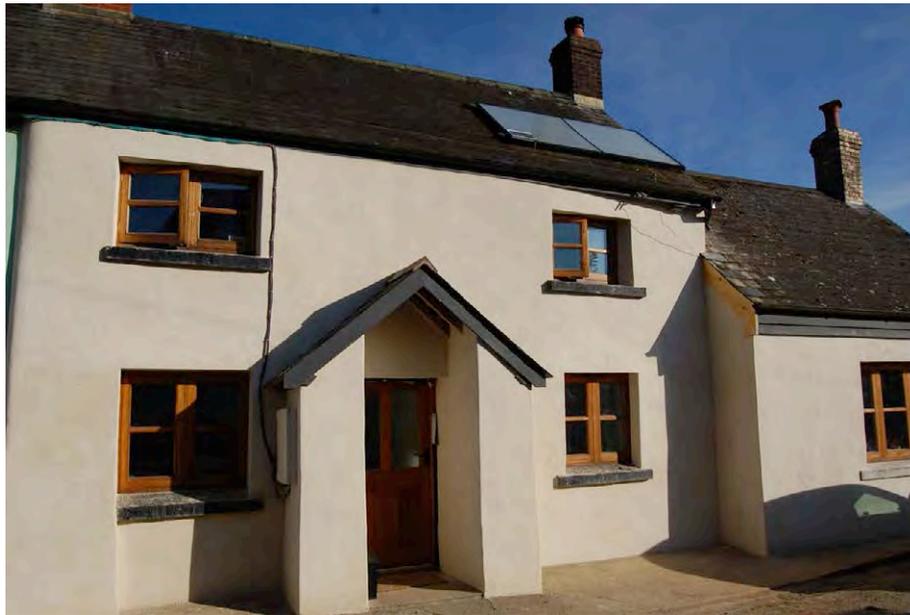
2.3. The Firs, Riddlecombe, Devon - 2015 - 16.

Description: Two-storey, semi-detached, nineteenth-century cob cottage with early twentieth-century single storey addition in cob to east side and more recent extensions to rear. Mainly new timber double-glazed units.

Refurbishment: Work at The Firs, Riddlecombe included the removal of external cement render, walls were repaired and re-rendered with a perlite-based insulating lime render. Internally gypsum plasters have largely been replaced with lime and limewash finishes. Floors in the older part of the house have been insulated. Particular attention has been paid to air tightness detailing through the house.

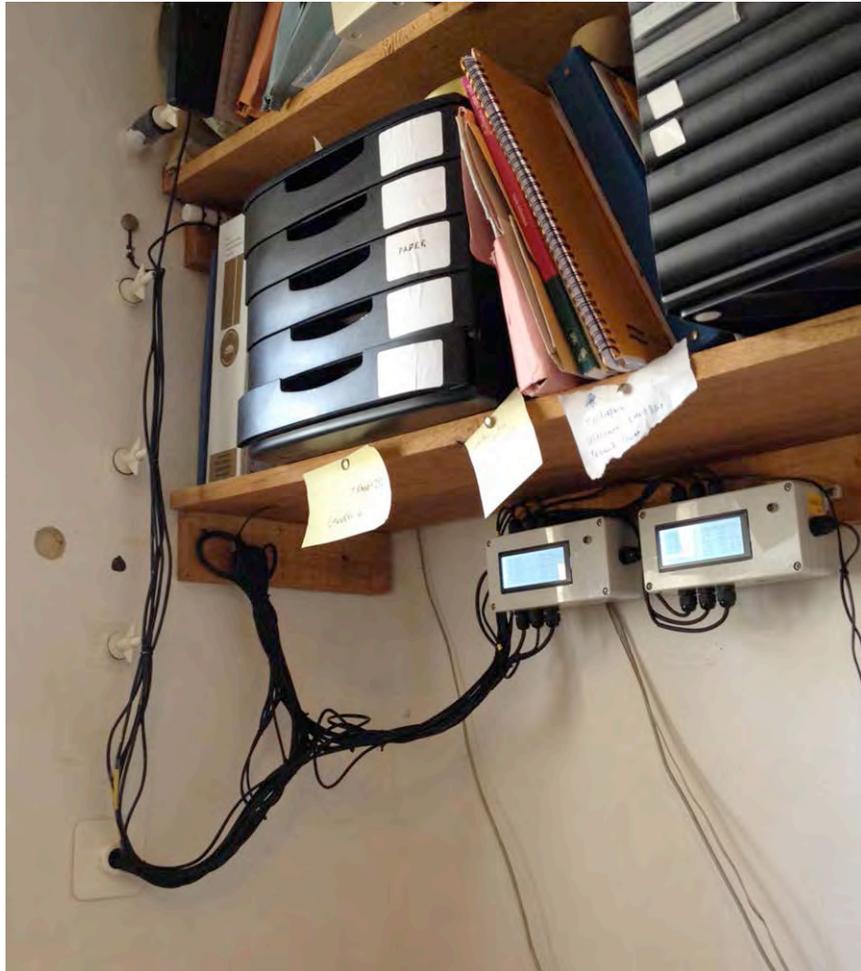
Figure 32. Interstitial Hygrothermal Gradient and Material Moisture Monitoring, Riddlecombe.

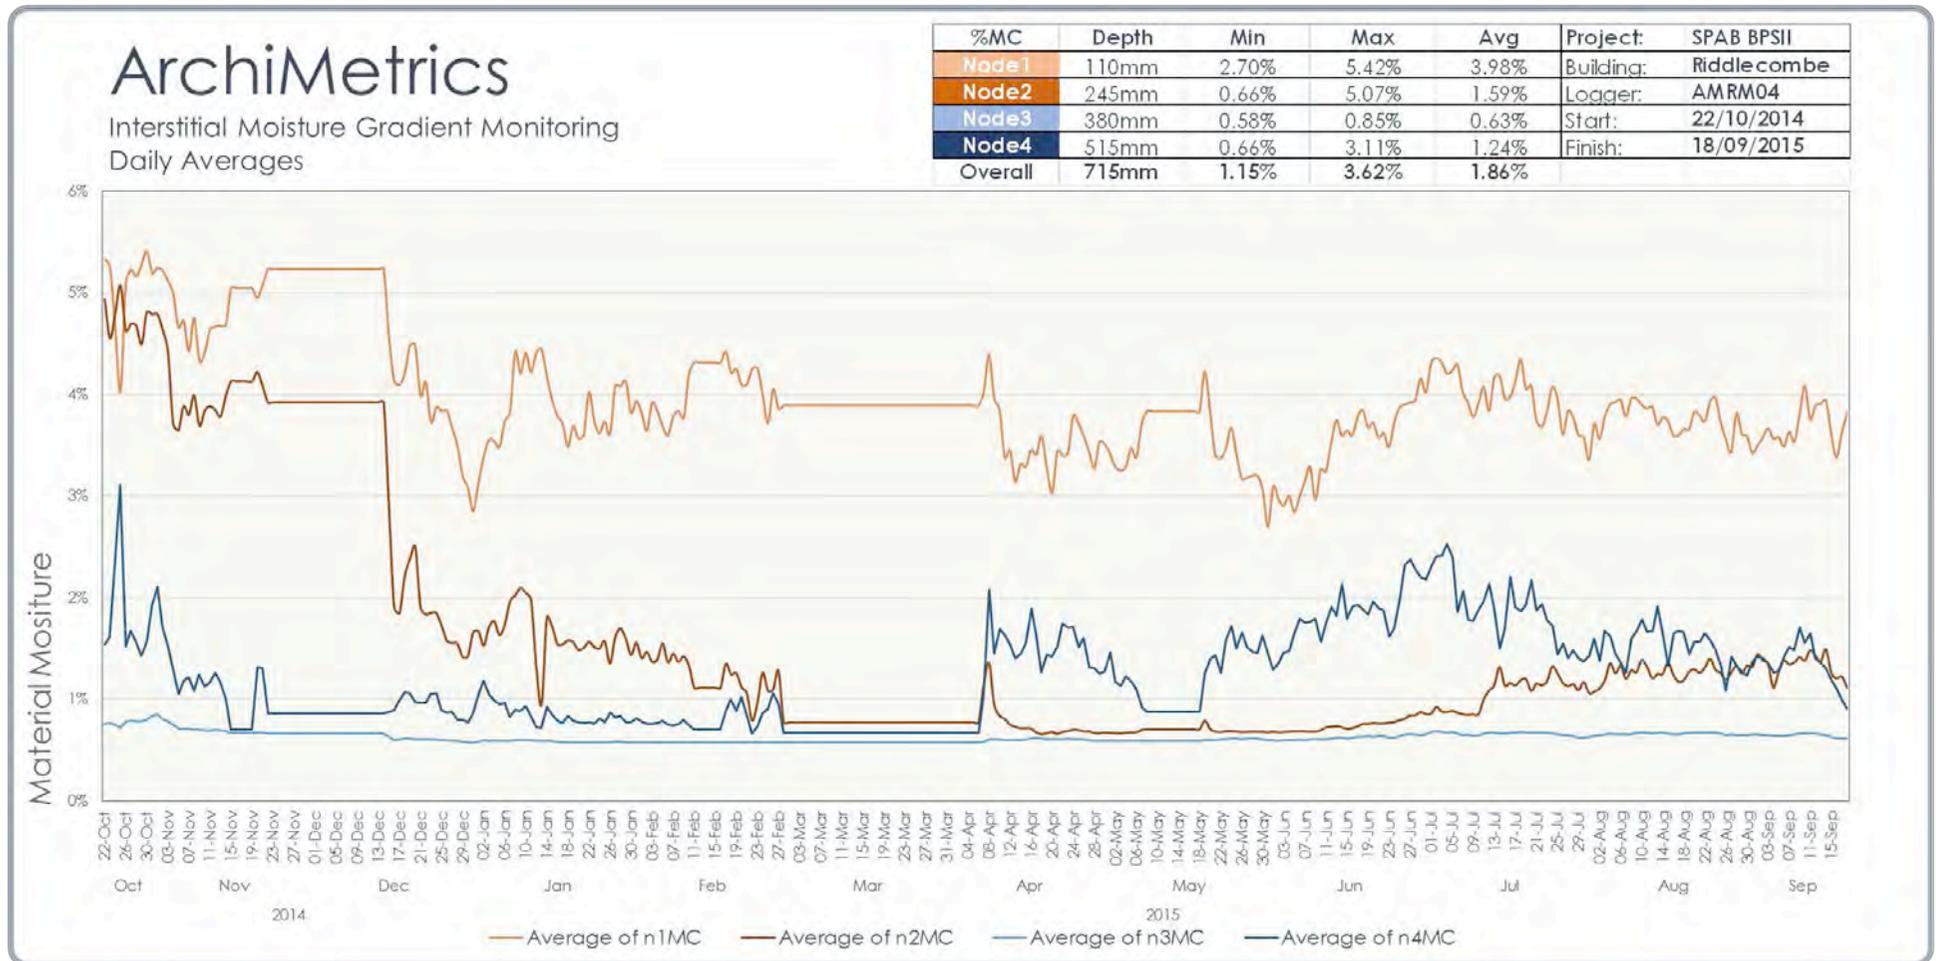
Figure 42: Material moisture content over time, The Firs, Riddlecombe 2014 - 2015
