Preventing firefighter & evacuee entanglement, electrocution, and obstruction risks in timber buildings on fire

A study for the Fire Service Research & Training Trust investigating and solving the problem of early loss of loadbearing capability of fixings holding M&E services to timber ceilings

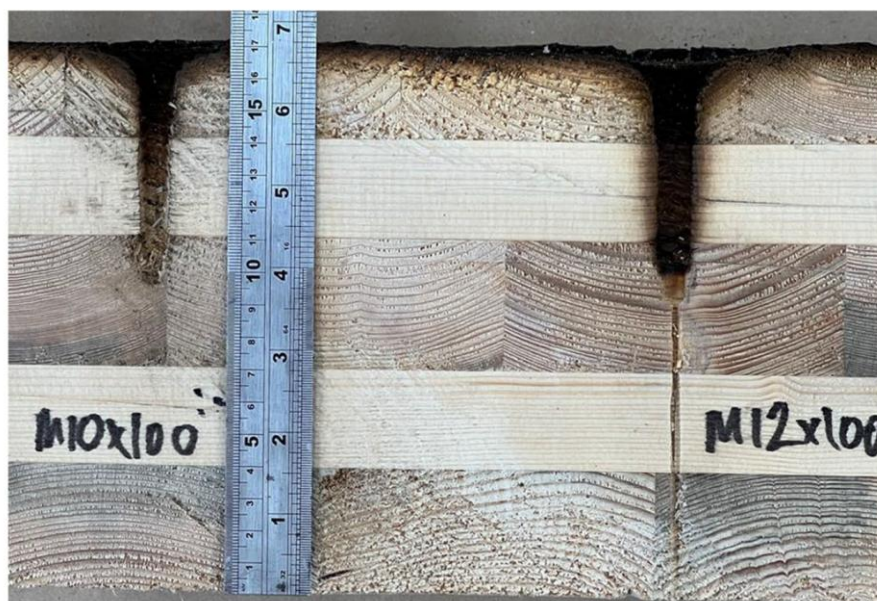
Figure 3 Post test cutaway showing heating and charring of wood around the bolt threads

The results showed a marked loss of strength by the fixing before and after fire that was disproportionate to the amount of surface charring of the CLT in comparison to the fixings embedment depth in the timber. Whilst char formation as described in Figure 1 is a relatively slow process, large screw fixings are able to conduct the fire heat deep into the CLT to raise temperatures and weaken wood local to the fixing's screw threads. To this end, for large diameter fixings, such as those specified in many M&E applications only millimetres of heated wood and char around the threads must form to for complete loss of retention capacity to occur as shown in Figure 3.

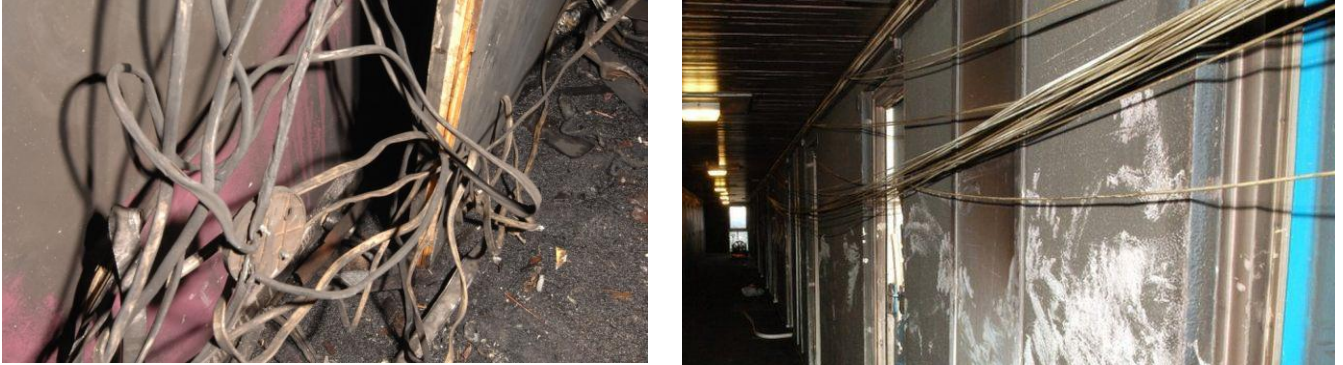
Figure 5 Fallen cable at Shirley Towers

featured a complex 'scissor section' layout that made navigation difficult. The fire began when curtains ignited from contact with an uplighter lamp. As crews entered the flat, they encountered extreme heat (over 1,000°C), zero visibility, and a disorienting layout. The situation was worsened by falling electrical cables, which had melted from the heat and obstructed escape routes. These conditions contributed to the firefighters becoming trapped and ultimately succumbing to the intense heat.

This change directly addresses the hazard that contributed to the deaths of firefighters at Shirley Towers, where plastic trunking melted, causing cables to fall and entangle crews trying to escape. In respect of fixing M&E to mass timber ceilings the problem is 'the same but different'. In the case of Shirley Towers, a traditionally constructed building, the issue was one of fire-weak (plastic) fixings secured into a strong substrate (concrete). For timber ceilings, the fixings are very strong (steel) but the timber substrate weakens greatly under the action of fire. The causes are different, but the outcome is the same and sadly, the amendments to wiring regulations made following the Shirley Towers incident do nothing to protect against this new challenge – that will require further regulation change.

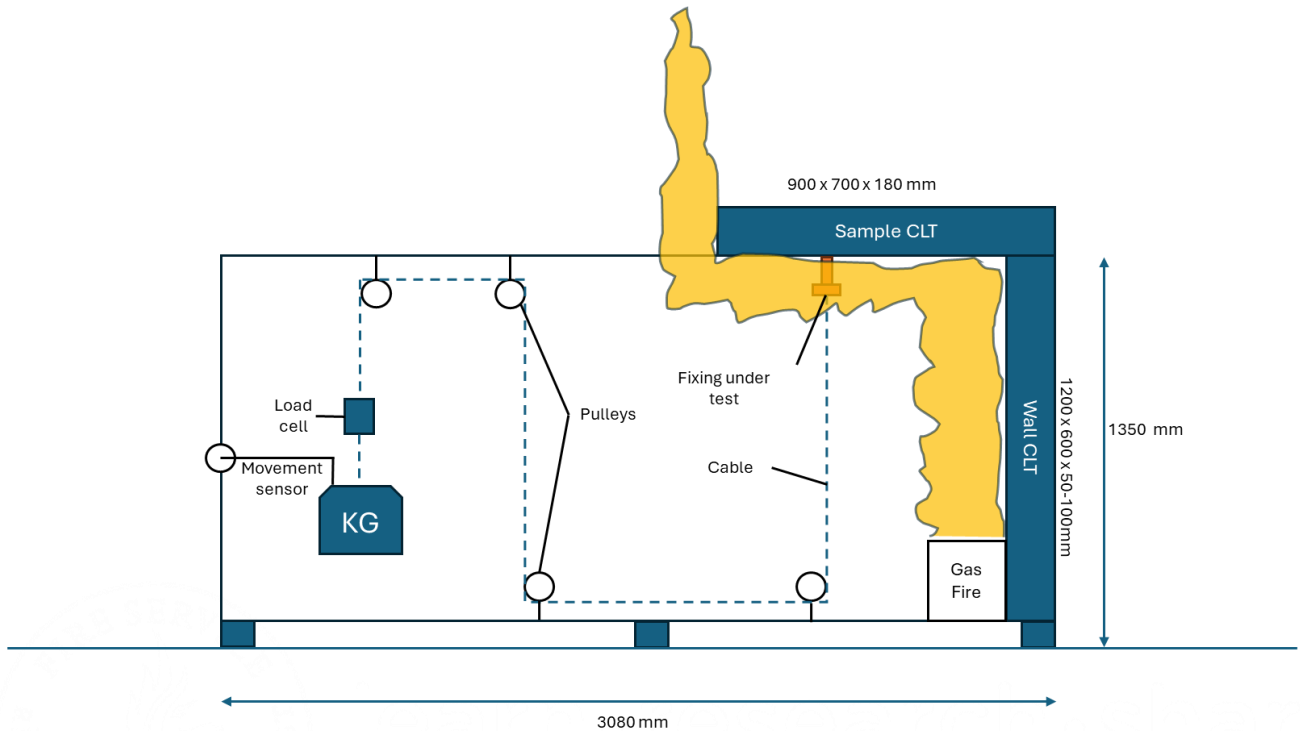
Figure 6 Schematic of test rig

The test rig was designed to allow for the simultaneous testing of 3 independently loaded fixings during each test. A crude diagram of the rig is shown below with detailed frame schematics given Annex A.

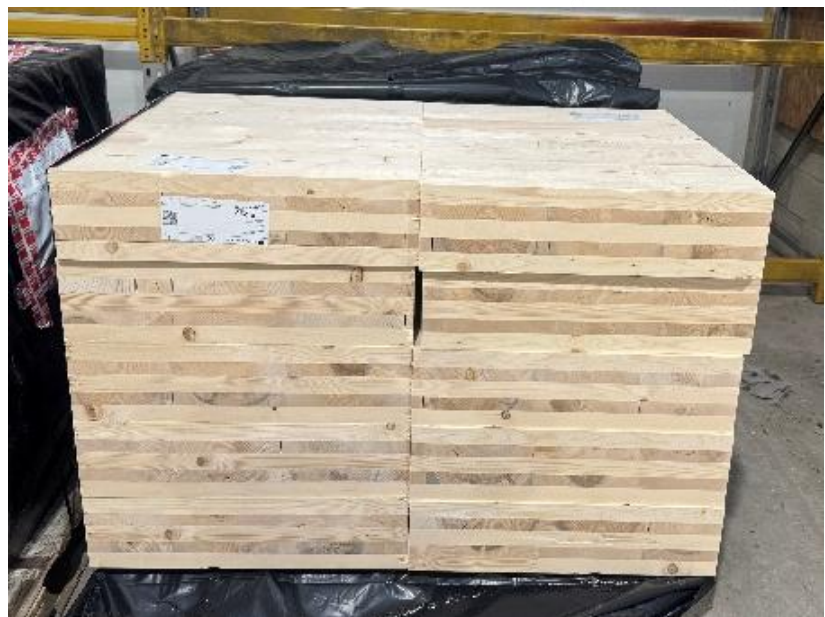
Figure 7 CLT samples

Ceiling panels:	Width	700mm
	Length	900mm
	Thickness	180mm
	Ply	5 (40/30/40/30/40mm)
	Lamina	Surface ply to be running across the sample width
Wall Panels	Height	1200mm
	Width	600mm
	Thickness	100mm
	Ply	3 (40/20/40mm)
	Lamina	Surface ply to be running across the sample width

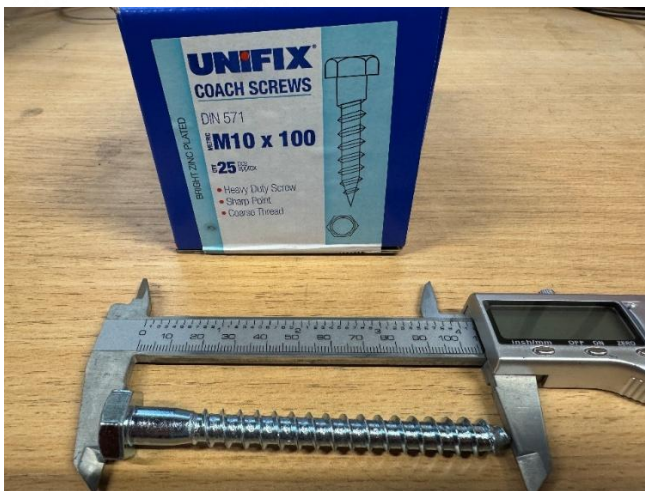
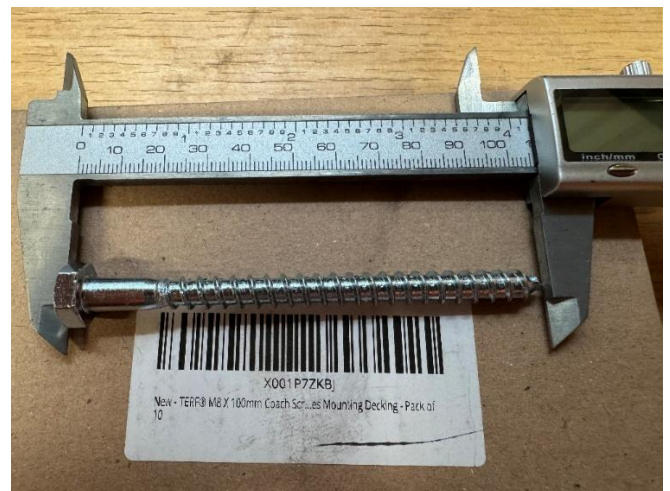
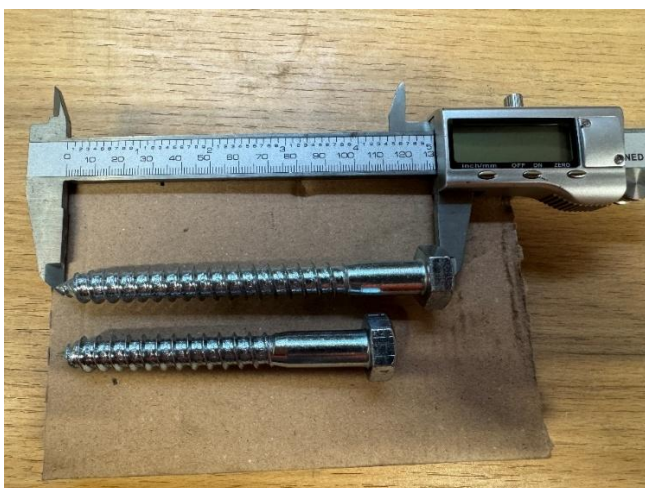
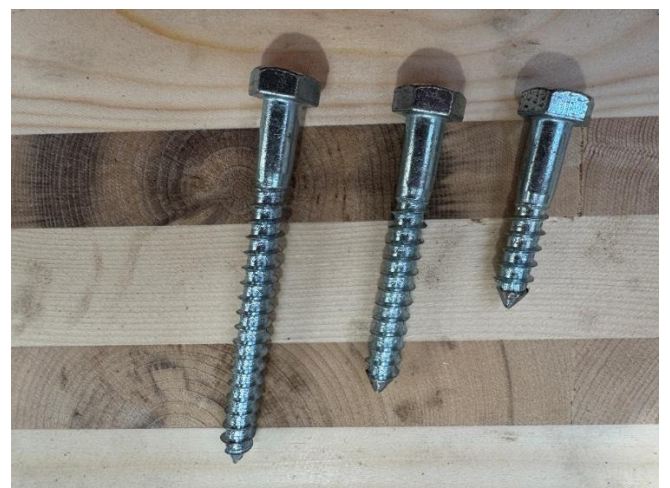
Figure 26 Hex Coach Screws

They are made of non-hardened steel and are characterised by having a coarse thread, hexagonal bolt head, and for all but the smallest sizes (M6 and below) require the drilling of a pilot hole. Photographs of the ones used in this study are shown in Figure 26. For the purposes of testing, where shorter samples were required, they were cut to size and sharpened as shown so the amount exposed to flame remain constant.

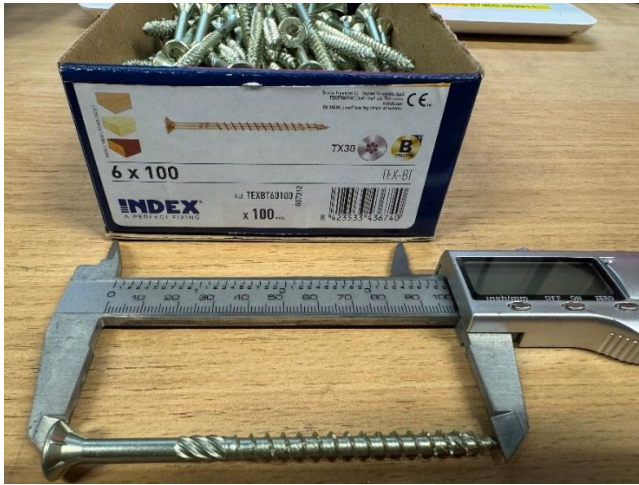
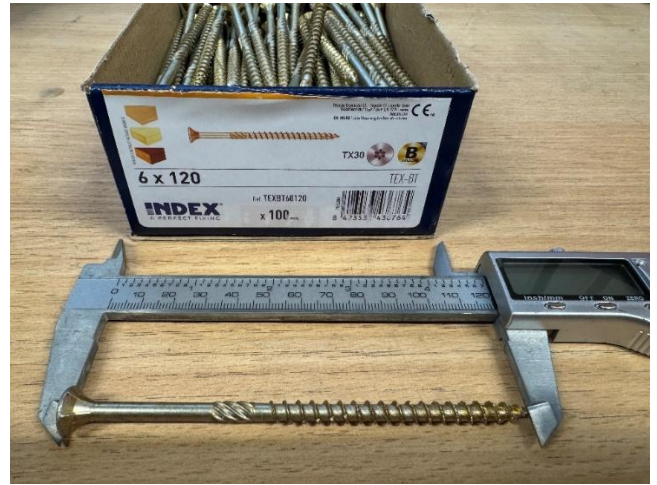
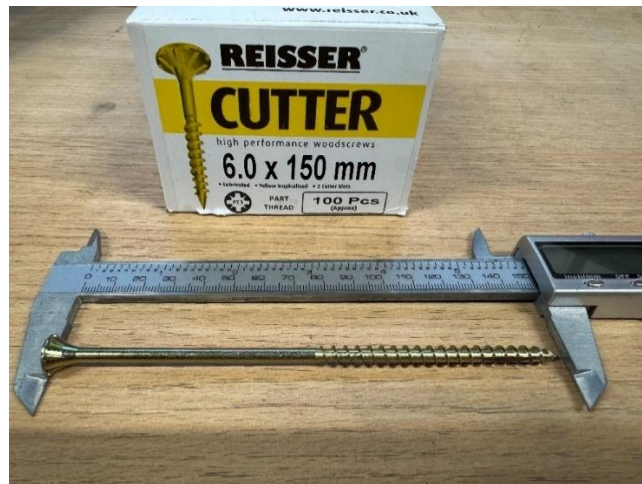
CST Screws are a high performance fixing for timber construction with high load bearing capacity. They are made of hardened steel and require no pre-drilling. Inbuilt into the design, to assist with insertion of these often-long fixings, is a torx drive, cutter point, milling thread, and glide coating.

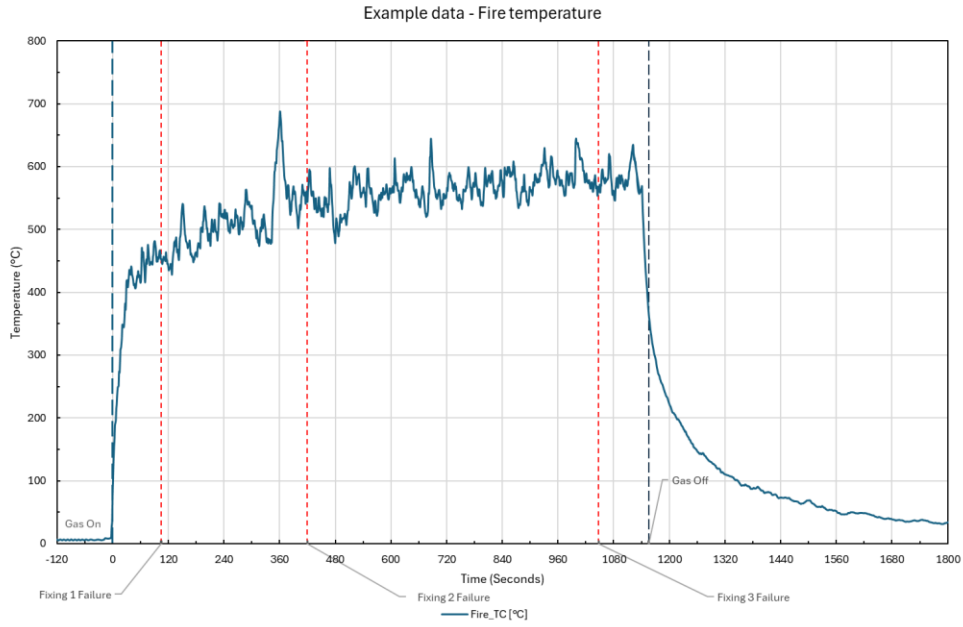
The gas fire temperature is measured by a thermocouple mounted directly above the gravel bed. Its purpose is to define the time between the gas being turned on and ignited, and being turned off.

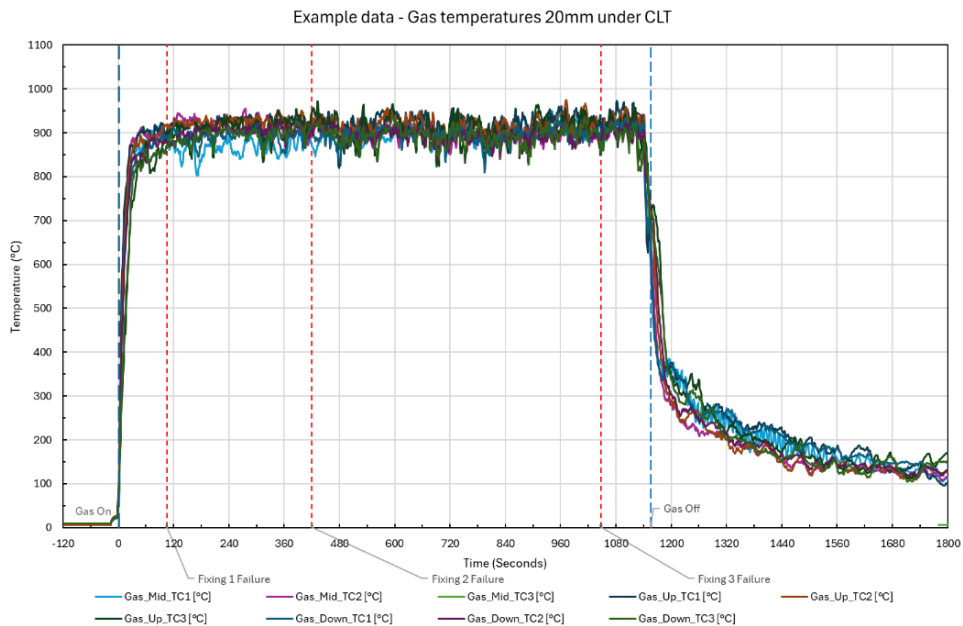
6.2 Under-ceiling gas temperatures

Gas temperatures 20mm under the original surface of the ceiling are measured by thermocouples mounted down through the CLT from the top surface via pilot holes. This is a key value for determining uniformity of fire challenge over the CLT surface and providing a key comparison value with historically conducted full-scale tests.

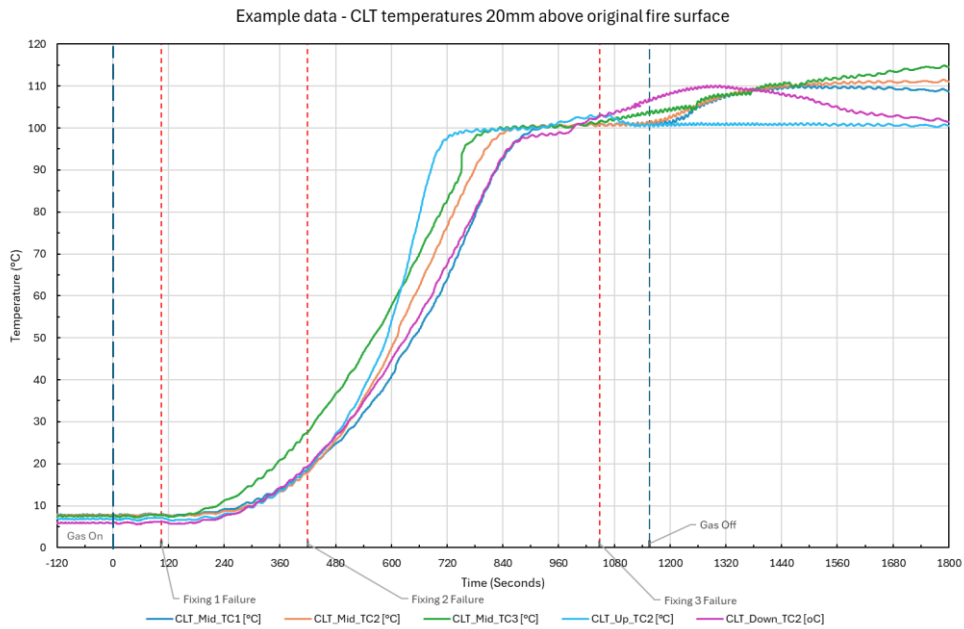
6.3 In CLT temperatures

CLT temperatures 20mm from the original surface of the ceiling are measured by thermocouples mounted within the CLT from the top surface via pilot holes. This is a key value for determining uniformity of fire challenge over the CLT surface and understand the rate of heat absorption into the CLT that influences timber's load bearing capacity. These values can be compared to the insertion depth of the fixings under test.

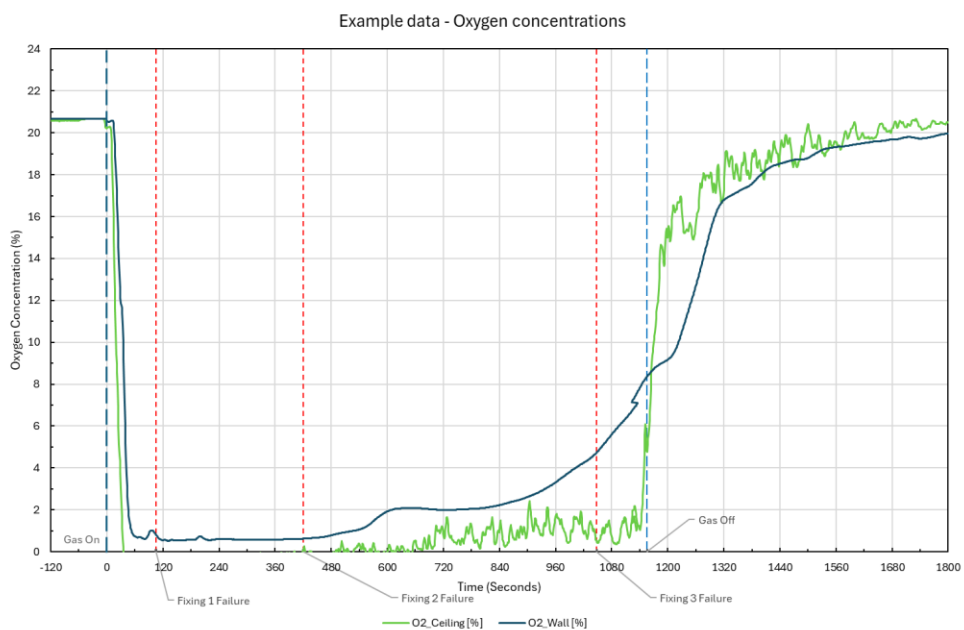
6.4 Oxygen measurement

The measurement of oxygen at the CLT's surface assists with the understanding of factors that influence rate of burning.

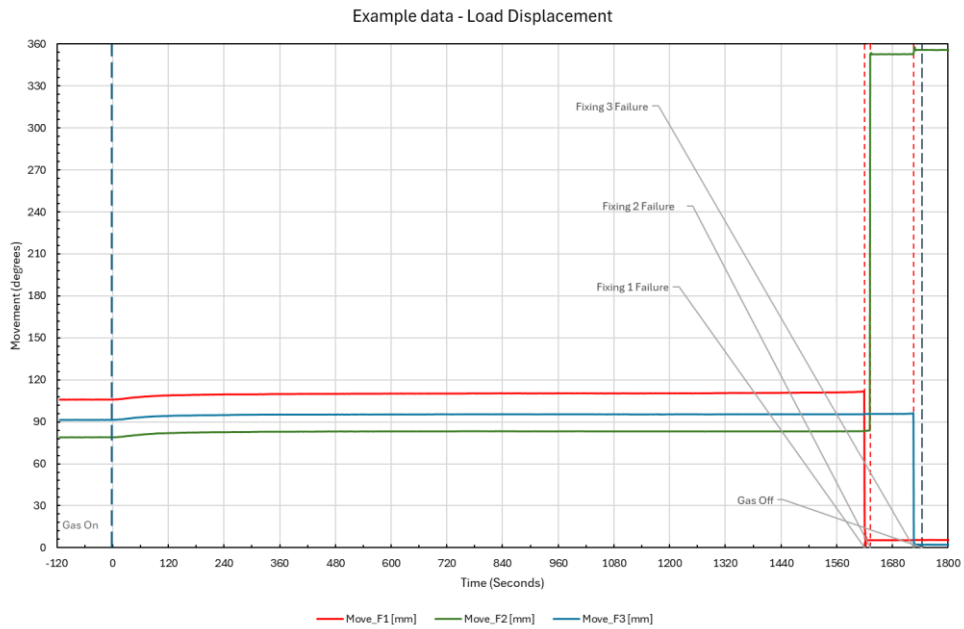
6.6 Load displacement

In an attempt to ascertain the mode of failure of the fixings rotational sensors were attached to each of the three steel cables via pivot bars. The intention was to understand better if fixing pull out was a gradual or sudden process. These results provided the most accurate timing for fixing failure.

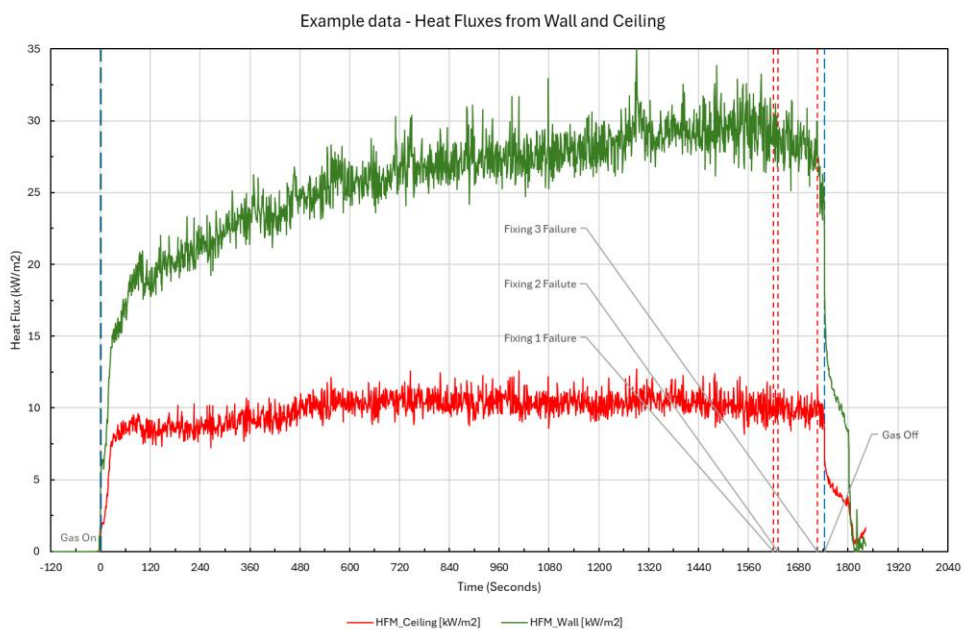
6.7 Heat fluxes

Heat flux sensors pointed at the ceiling and wall CLT sections recorded heat flux from the surface as an aid to understanding the challenge presented and the consistency of rig operation.

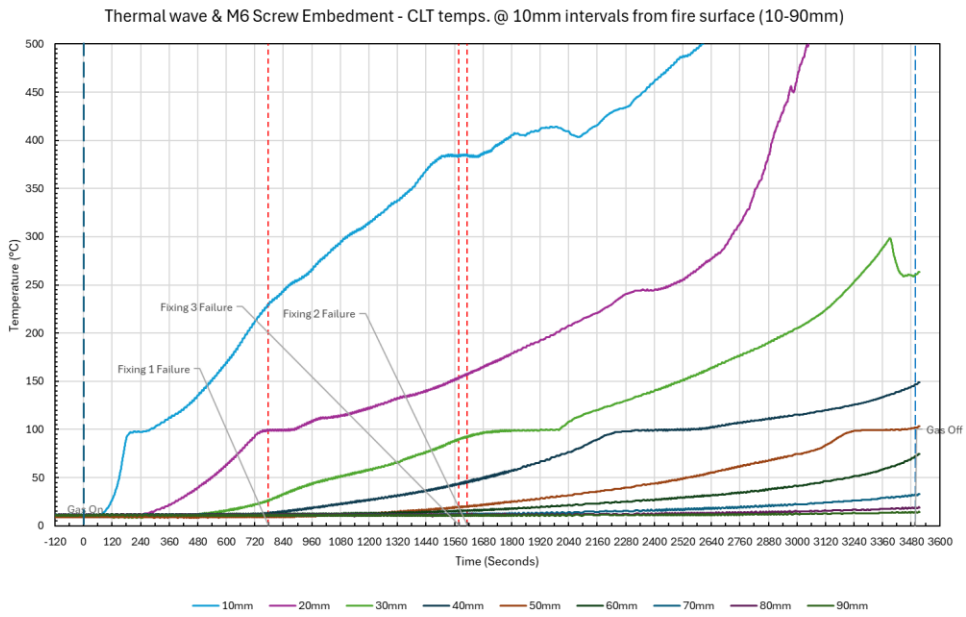
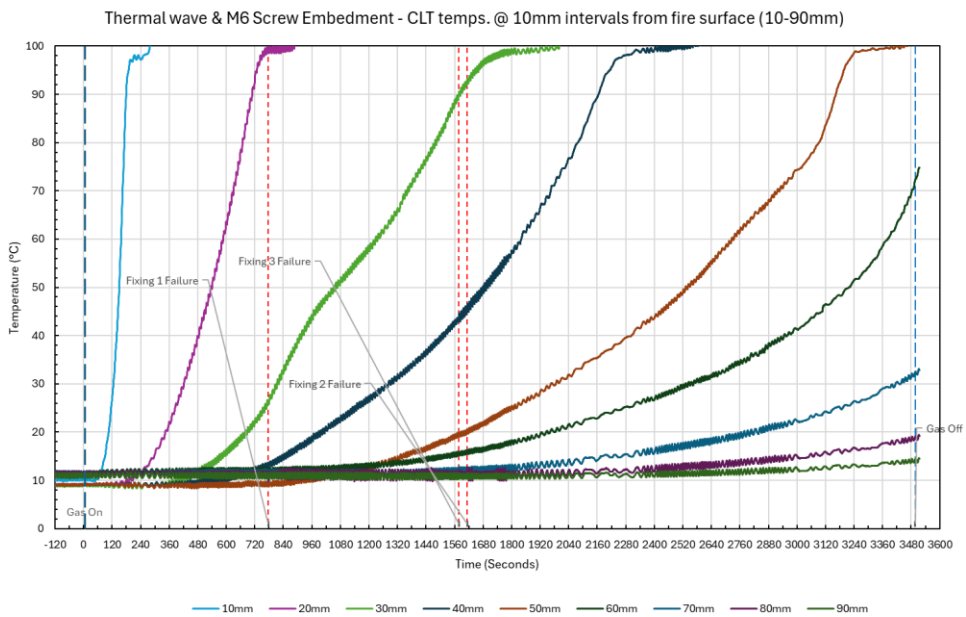
Figure 30 Temperature profile within CLT for thermocouples mounted between 10mm and 90mm from the original ceiling surface

- The pause in heating at 100°C from moisture being driven from the timber is very apparent
- Within the time period of 1 hour the 100°C threshold is never reached for depths greater than 50mm
- Above 100mm depth there is no measurable change in the temperature of the CLT meaning that at this time the original hold capability of any part of a fitting at this depth would be unaltered subject to there being no conduction of heat down the fitting.

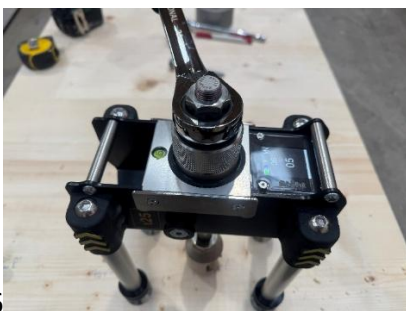
6
Figure 33 Load pull out equipment

As a benchmark, the load retaining capability of all tested fixings and configurations, was appraised using an industry standard pull-out tester hired for the purposes of this study. The device provides for a stable attachment to the surface, a means of gripping the fixing head and applying force, and a load cell to measure that force. The device records the maximum value attained before the load drops following failure and dislodgment.

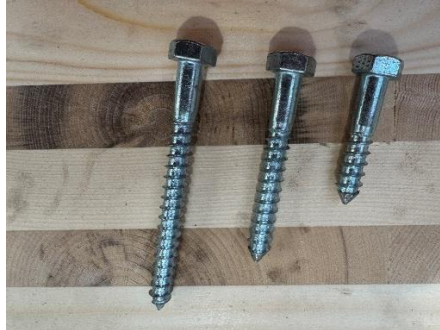
Figure 35 M12 embedment test Hex Coach Screw fixings

The impact of embedment depth was assessed using 100mm M12 Hex Coach screws cut down to size to give the same amount of protrusion (10mm) below the CLT ceiling. This is necessary to ensure that the results are not influenced by any differences in heat collection from the flame zone resulting from different protrusion lengths.

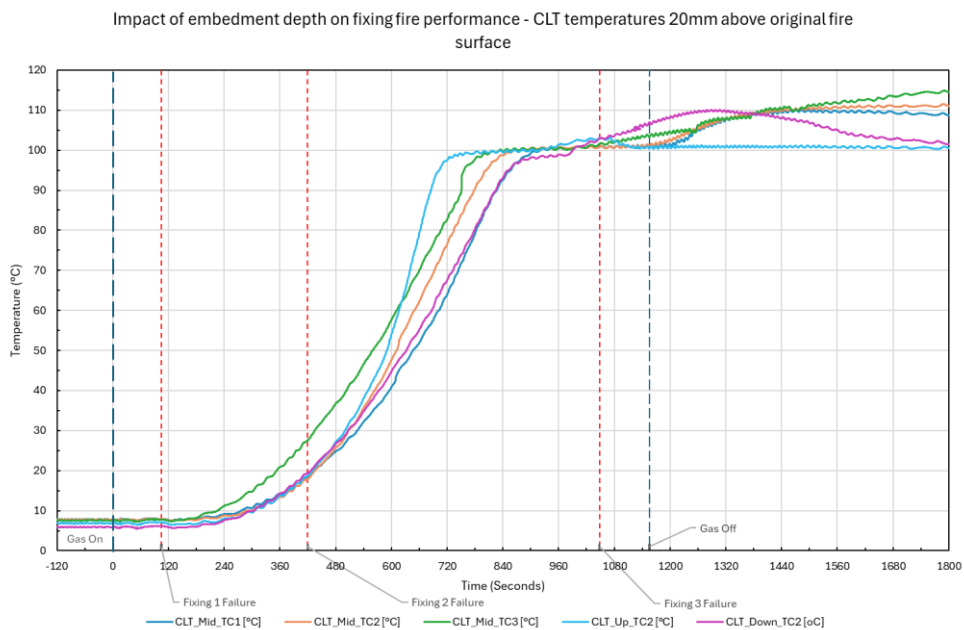
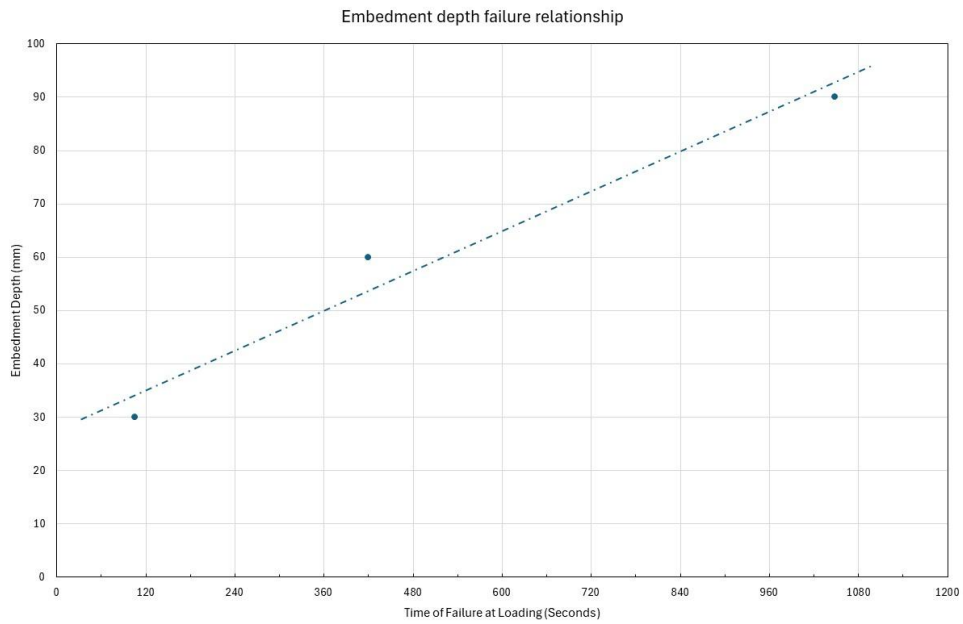
A clear relationship is shown of increasing retention capability with embedment depth but in every case:

- The fixing fails when restraining only a fraction of its non-fire measured capacity
- CLT temperatures are low or unchanged at the time of fail suggesting that timber heating that leads to loss of strength is occurring local to the fixing and its threads

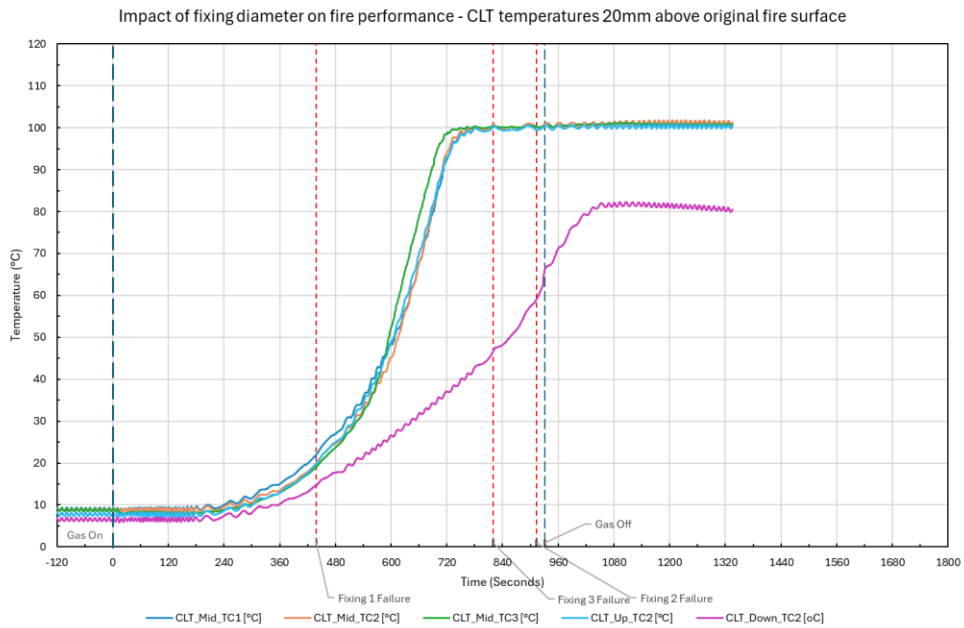
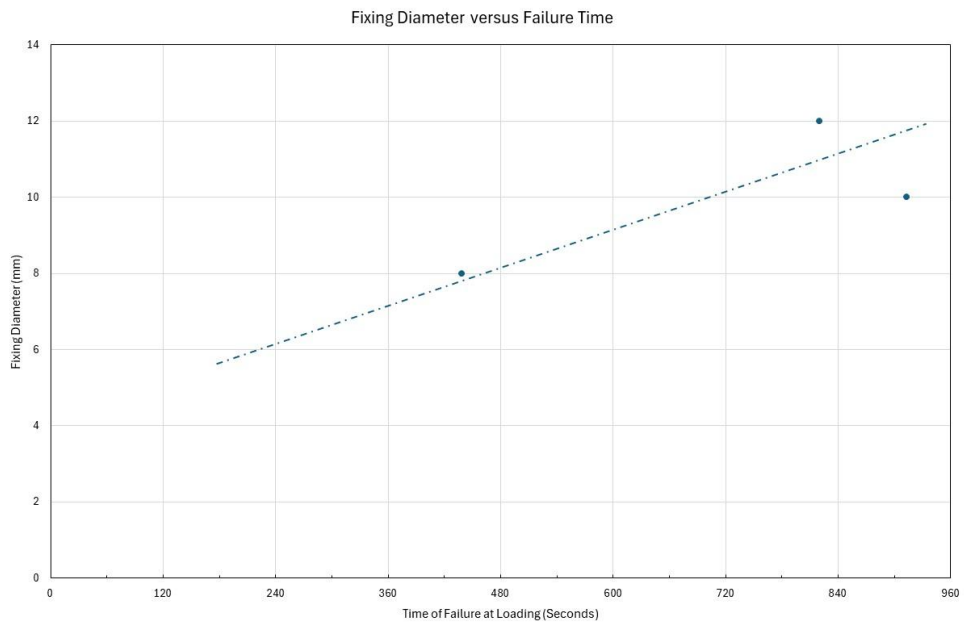
A clear relationship is difficult to discern because the smallest diameter fixing failed through a different mechanism to the other two, melting as opposed to pull-out (an important finding). That said, again all fixings failed whilst supporting only 1/10th of their ambient (non-fire) load bearing capacity. At the time when the two larger diameter fixings failed timber temperature along their length would have ranged from 250°C at their insertion point, to ambient at their tips (see Figure 30). The impact of conduction down the shank of these bolts is explored later.

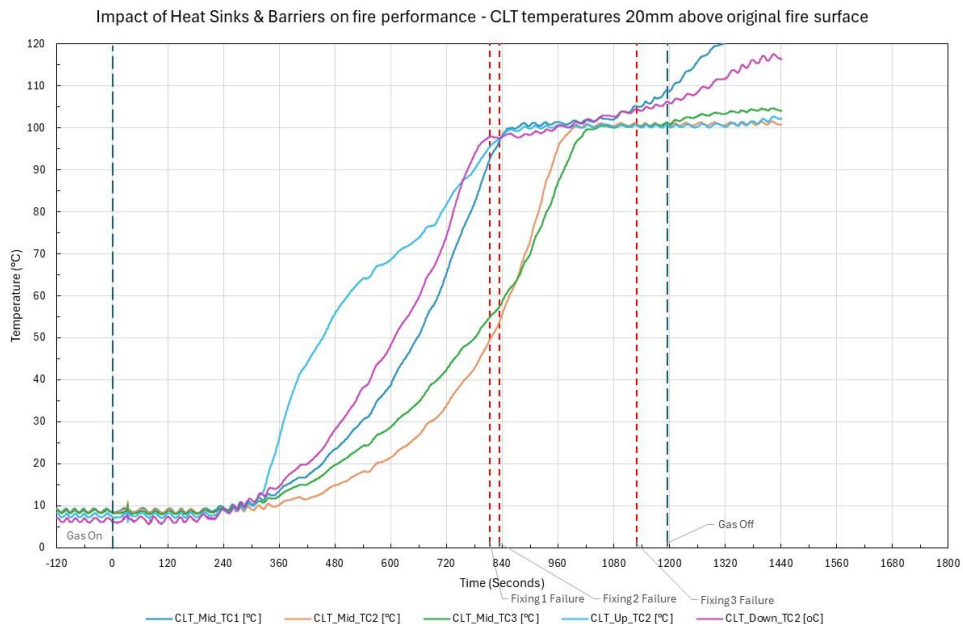
The data suggests that in this configuration the steelwork attached to the fixing is acting as a baffle against heat uptake by the fixing or having only a minor impact. Failure time for the smaller baffles is noted to be very similar to that of a previous test with no metalwork in place. The largest baffle which shielded the fixing from flame to the greatest degree appears to afford some protection leading to an

increased retention period. However, again it is noted that all fail whilst holding in place only a small fraction of the mass they are capable of holding in the non-fire condition.

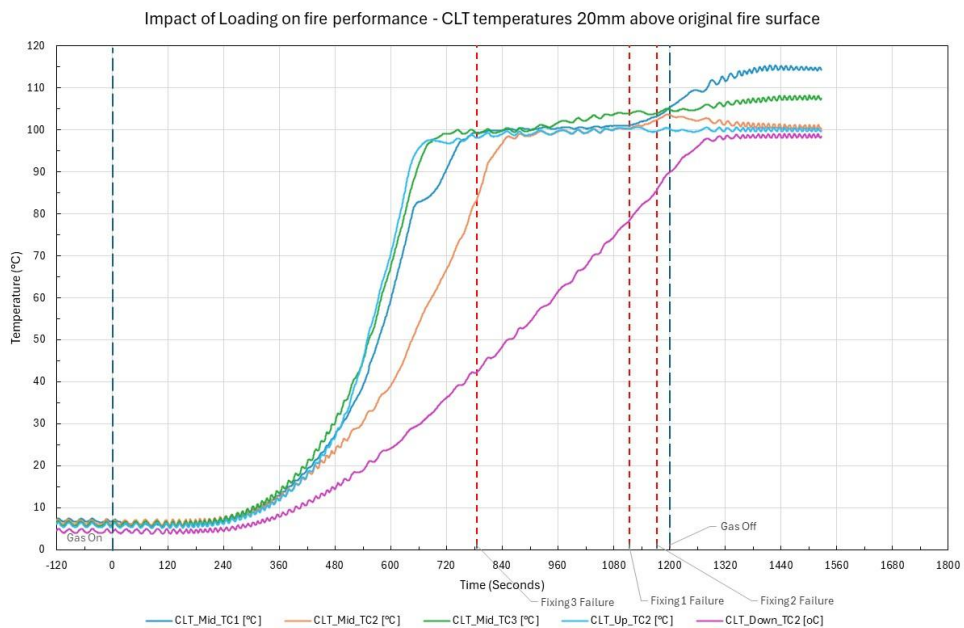
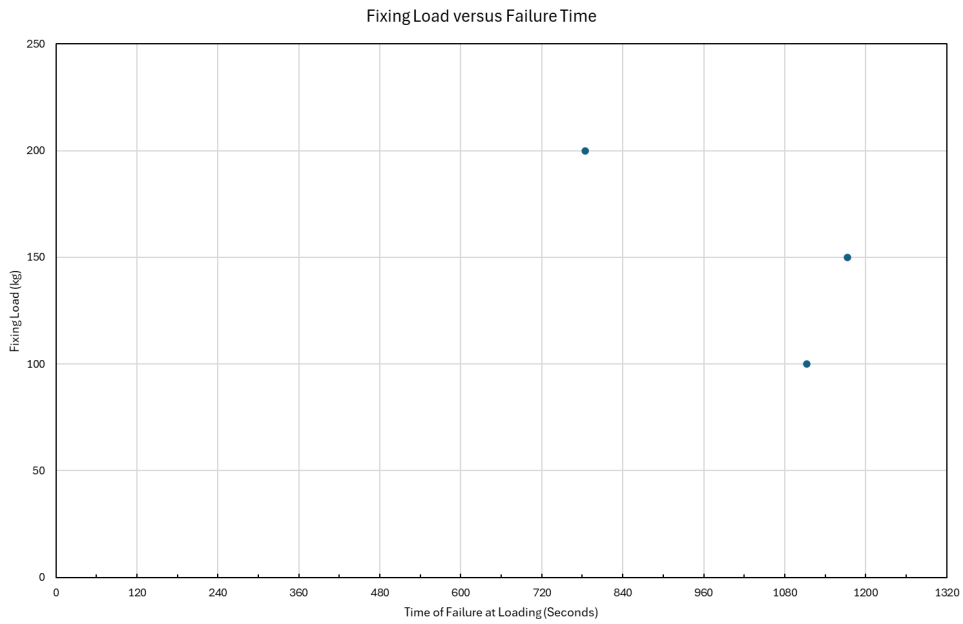
In this test the fixings with the greater loading of 150kg and 200kg are observed to break during the test. This introduces another interesting consideration for this project. Whilst the majority of failures are due to the weakening of timber around the fixing under the action of heat, there is also a need for the fixing itself to remain intact for the fire's duration. In spite of the fixings having an ambient loading capacity of 1560kg, they all experience either pull-out or structural failure at loads of under 200kg under the action of fire and within a short period of under 20 minutes.

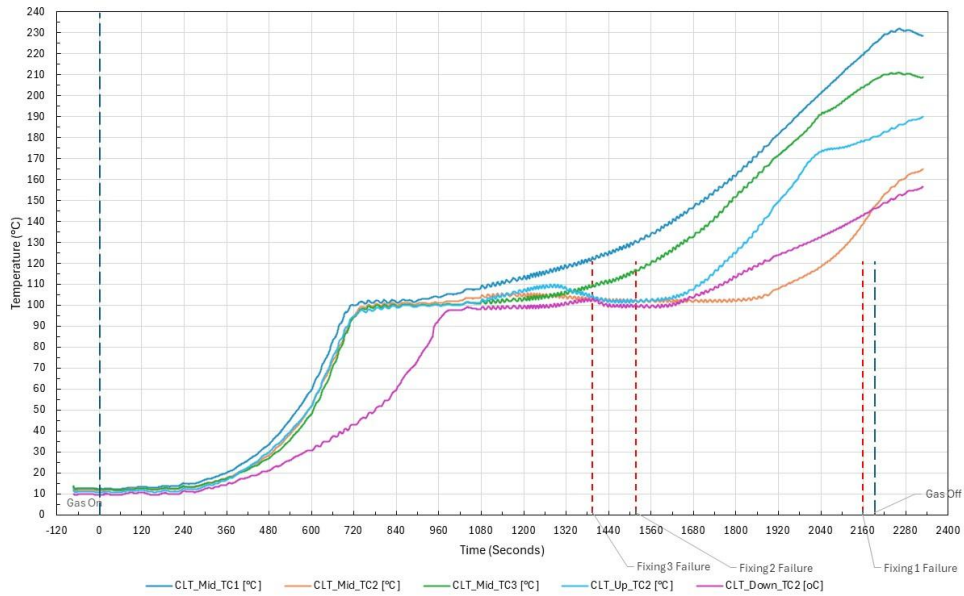
Impact of Light Loading on fire performance - CLT temperatures 20mm above original fire surface

Whilst a relationship does exist between the load the fixing is carrying and the time to failure it is not a strong one. When the high loading and low loading data is taken together it would seem that failure of fittings loaded to 20kg and 200kg fails on a similar timescale, and certainly with a period relevant to evacuation and fire service response.

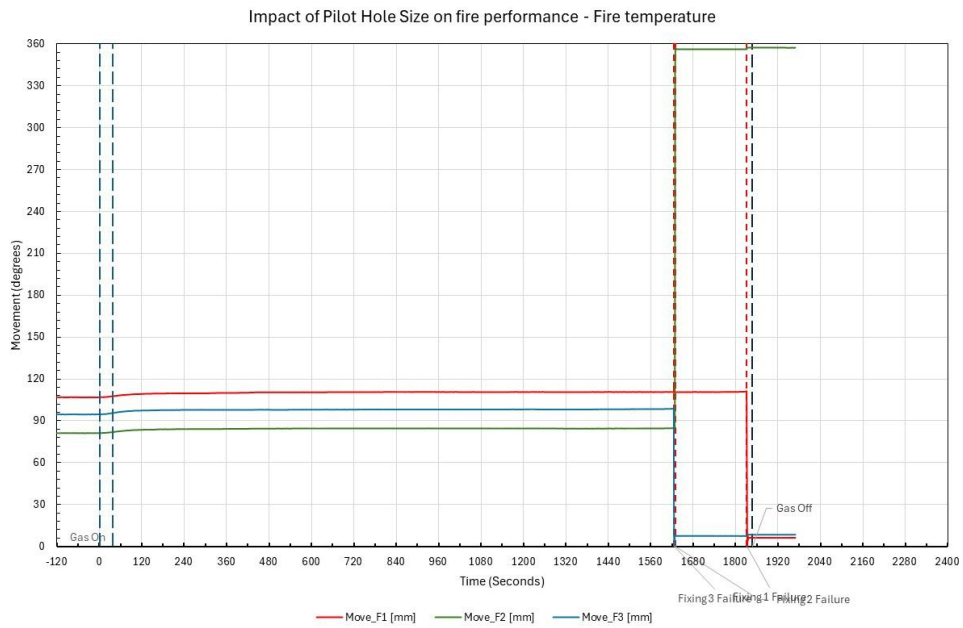
The size of pilot hole would be expected to exert an influence on both the ambient load bearing capability of the fixing, and during fire as this will impact the compression of wood around the thread of the fixing. It is clear from the data that the over-sizing of the pilot hole is deleterious to retention strength, but under-sizing it provides little or no additional benefit.

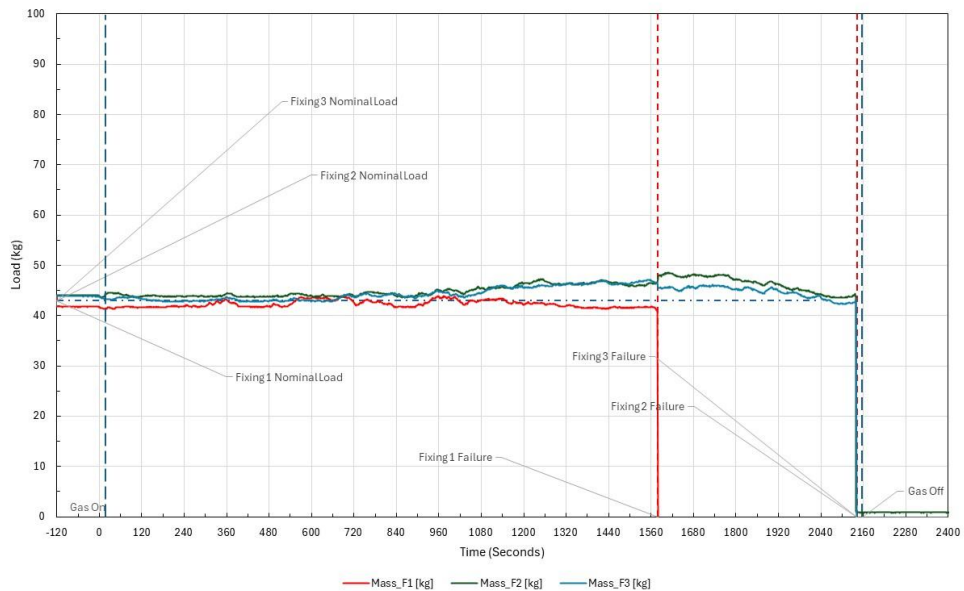
Coach Screw Pilot Hole study - Load on fixings

In this instance, a notable increase in performance was observed from the reduction of pilot hole size from 5mm to 3mm, but thereafter no improvement was observed when no pilot hole was used.

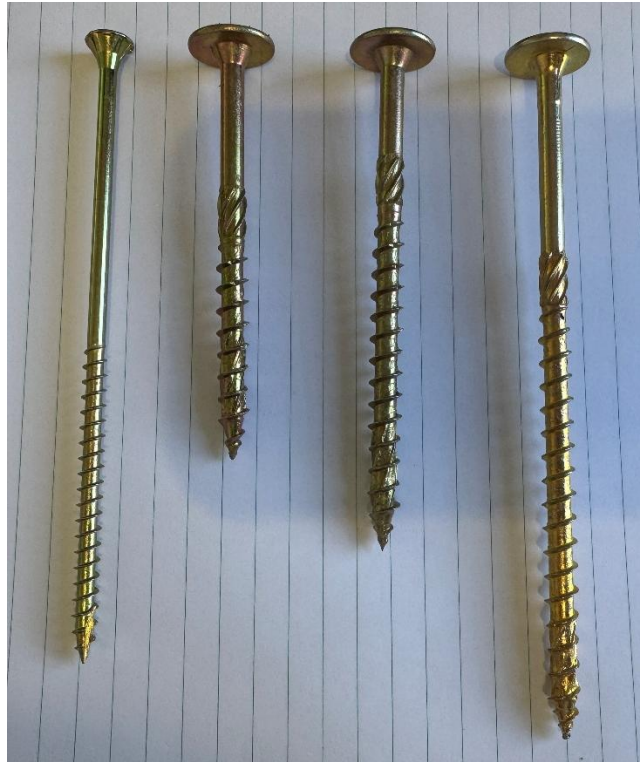
Unloaded post-fire strength assessment of short wide fixings vs. long thin fixings *On pull-out testing the head broke off due to twisting of the load testing device on the uneven charred CLT surface so retention would actually be better than the value supplied	Fixing	150mm M6 CST Screw	100mm M8 FST Screw	120mm M8 FST Screw	160mm M8 FST Screw
	Loading Mass	0kg	0kg	0kg	0kg
	Pilot dia. / depth	0/130mm	0/80mm	0/100mm	0/140mm
	Embedment	130mm	80mm	100mm	140mm
	Failure Time	----	----	----	----
	Failure Mode	----	----	----	----
	Ambient retention	917kg	989kg	1244kg	1529kg
	Post-fire capacity	785kg*	510kg	795kg	1325kg
	Capacity retention after 30min fire	86%*	52%	64%	87%
