# Preventing firefighter & evacuee entanglement, electrocution, and obstruction risks in timber buildings on fire

A study for the Fire Service Research & Training Trust investigating and solving the problem of early loss of loadbearing capability of fixings holding M&E services to timber ceilings

Author Prof. Jim Glockling

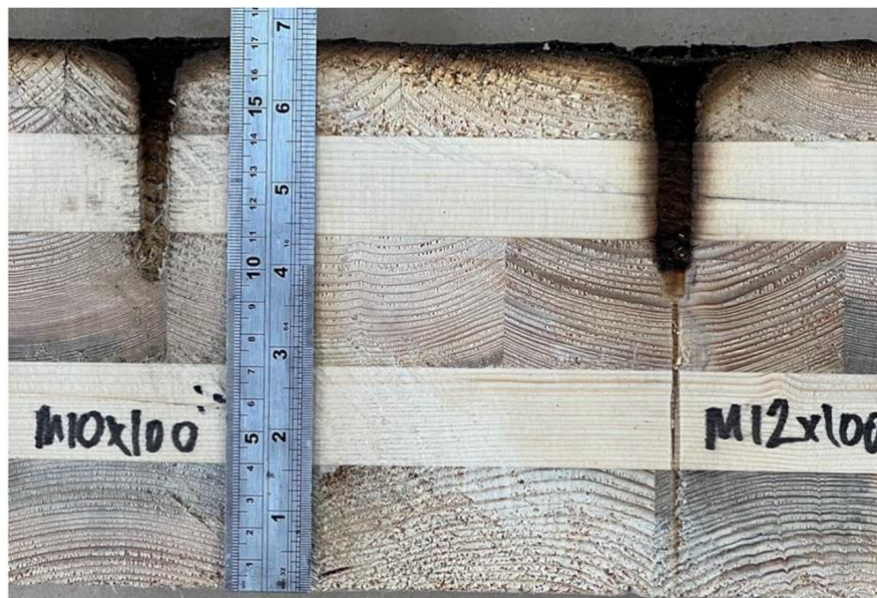
Figure 3 Post test cutaway showing heating and charring of wood around the bolt threads

The results showed a marked loss of strength by the fixing before and after fire that was disproportionate to the amount of surface charring of the CLT in comparison to the fixings embedment depth in the timber. Whilst char formation as described in Figure 1 is a relatively slow process, large screw fixings are able to conduct the fire heat deep into the CLT to raise temperatures and weaken wood local to the fixing's screw threads. To this end, for large diameter fixings, such as those specified in many M&E applications only millimetres of heated wood and char around the threads must form to for complete loss of retention capacity to occur as shown in Figure 3.

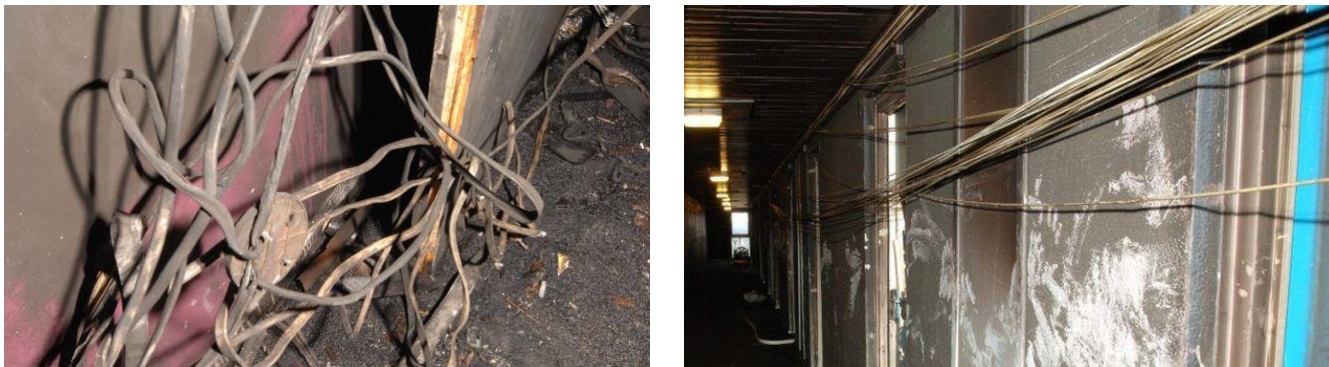
Figure 5 Fallen cable at Shirley Towers

This change directly addresses the hazard that contributed to the deaths of firefighters at Shirley Towers, where plastic trunking melted, causing cables to fall and entangle crews trying to escape.

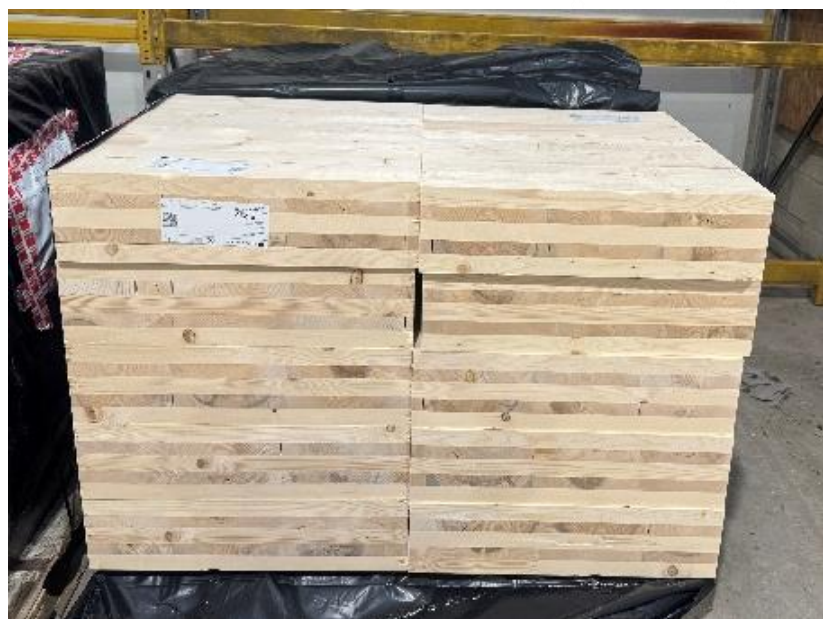
Figure 7 CLT samples

Ceiling panels:	Width	700mm
	Length	900mm
	Thickness	180mm
	Ply	5 (40/30/40/30/40mm)
	Lamina	Surface ply to be running across the sample width
Wall Panels	Height	1200mm
	Width	600mm
	Thickness	100mm
	Ply	3 (40/20/40mm)
	Lamina	Surface ply to be running across the sample width

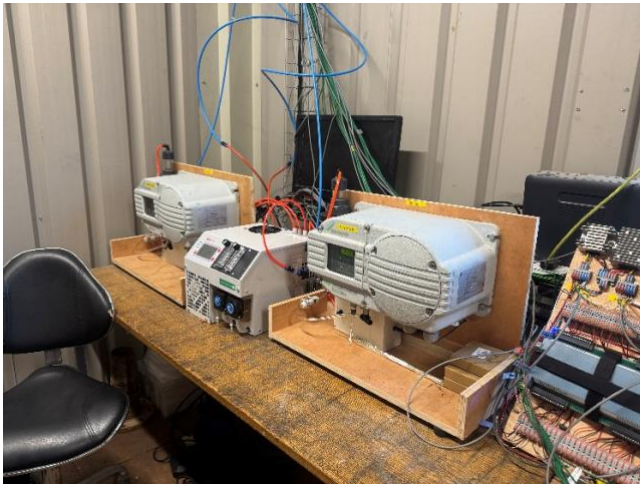
Figure 11 Gas analysis and conditioning system

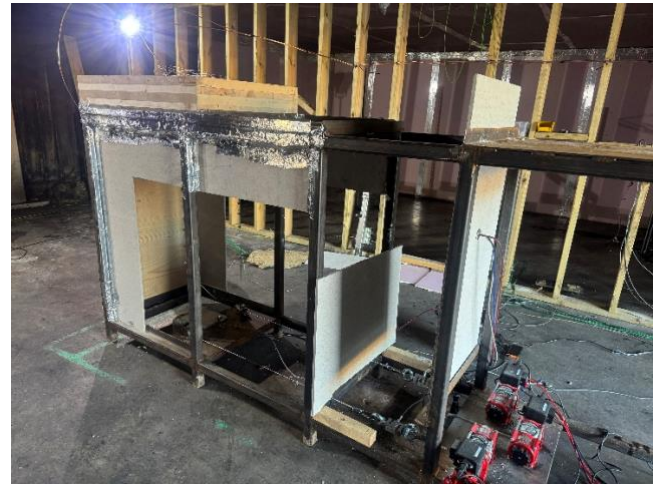
Figure 12 Side view of view with winch loading system installed

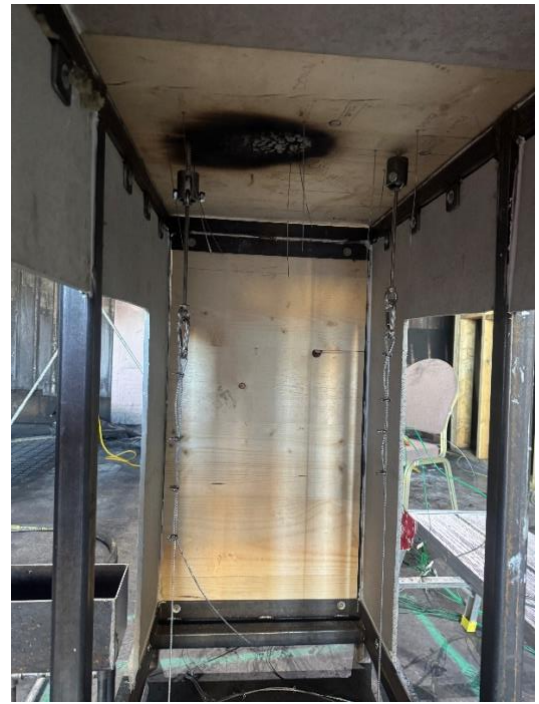
Figure 16 Fixing load hanger

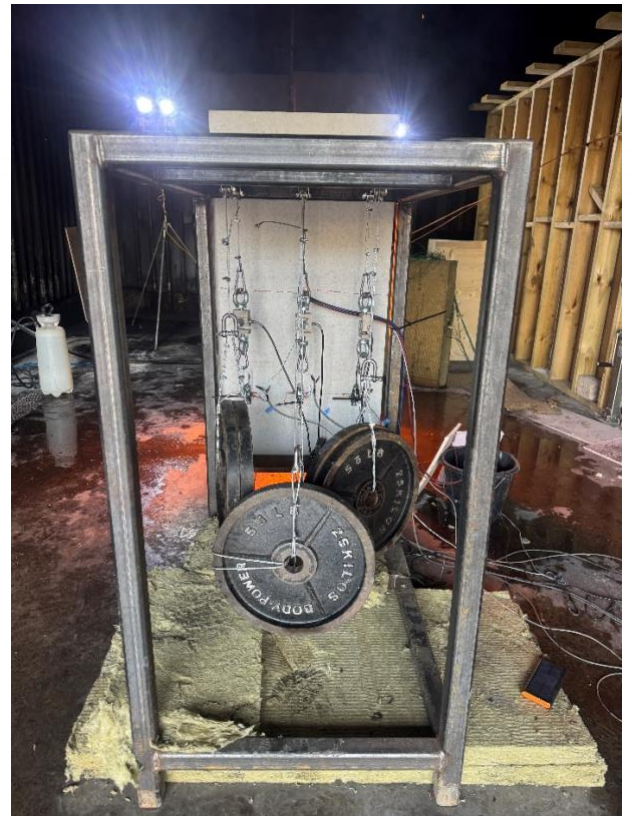
Figure 18 Loading end of rig with static weights

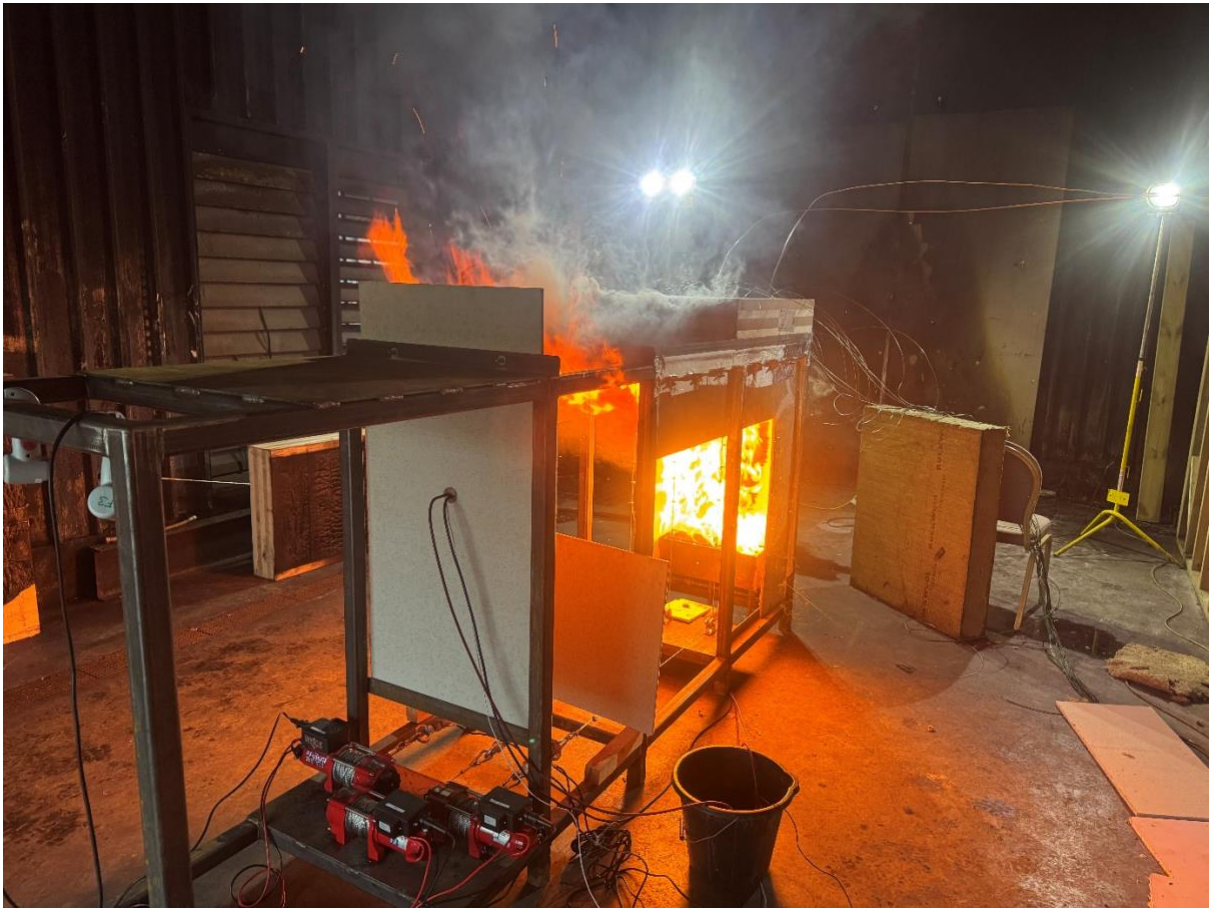
Figure 19 Rig in operation

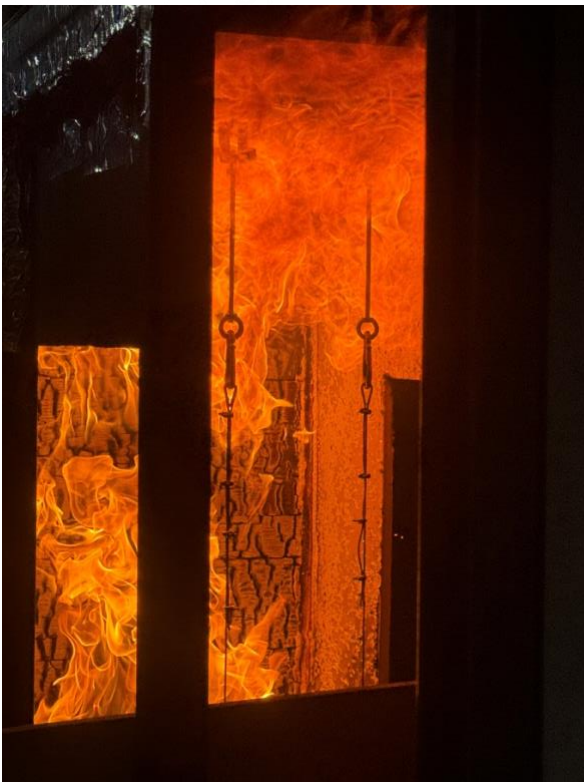
Figure 20 Loaded fixings under fire

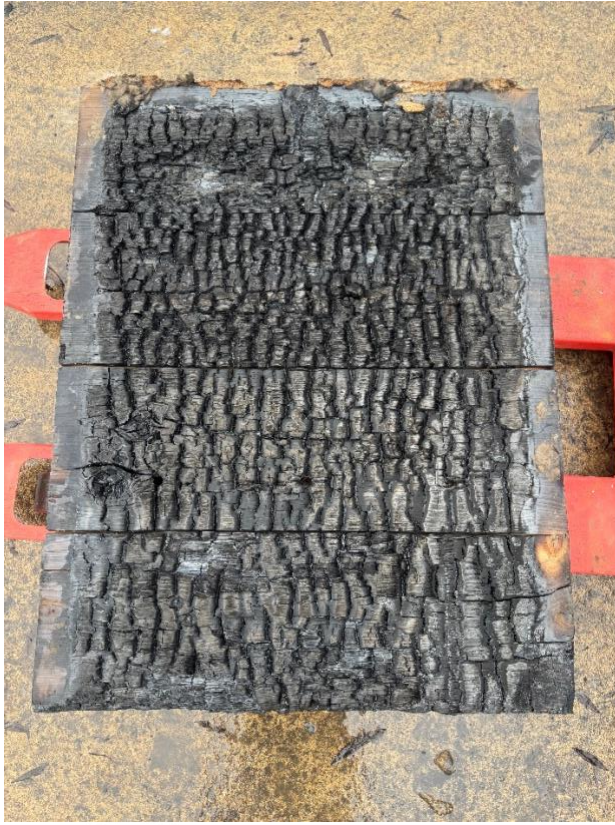
Figure 22 Ceiling panel post fire

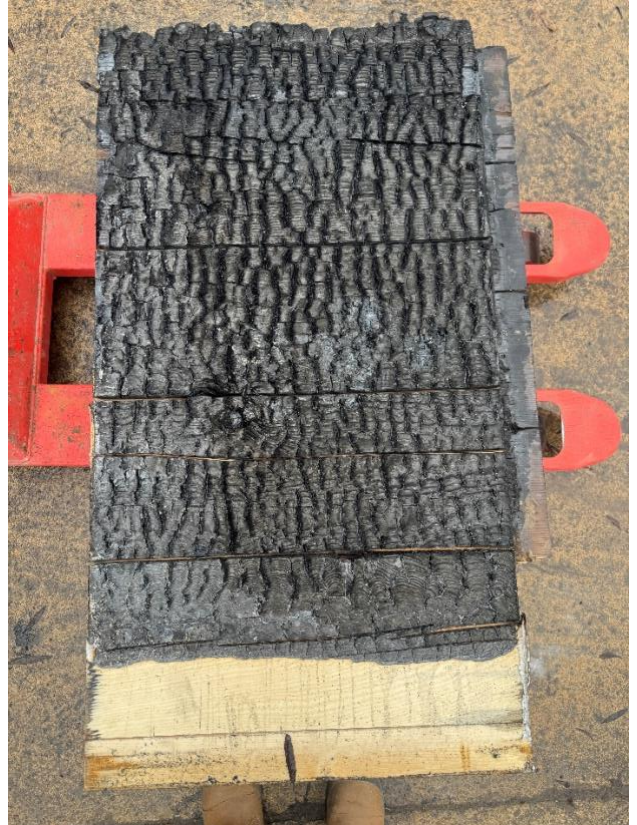
Figure 23 Wall panel post fire

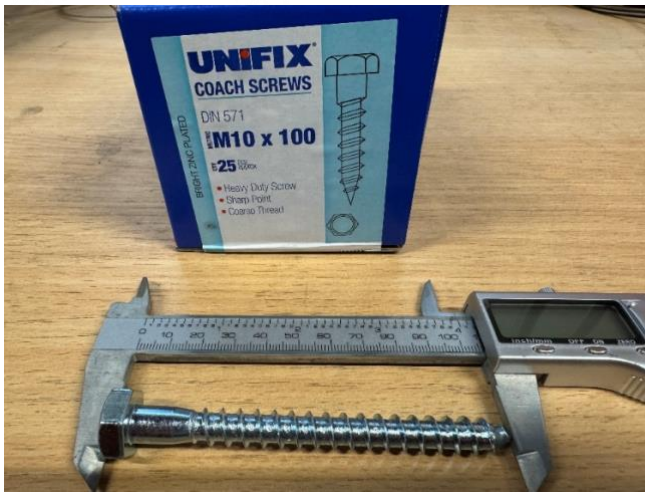
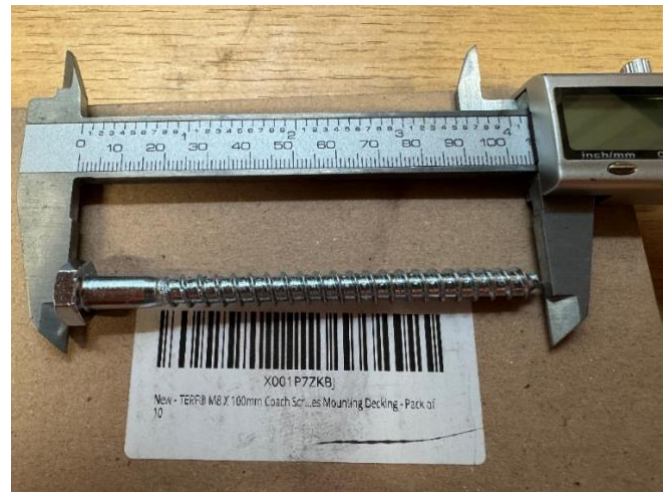
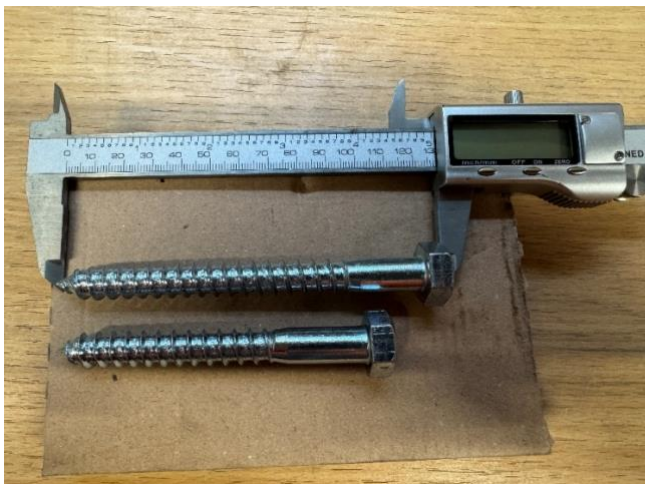
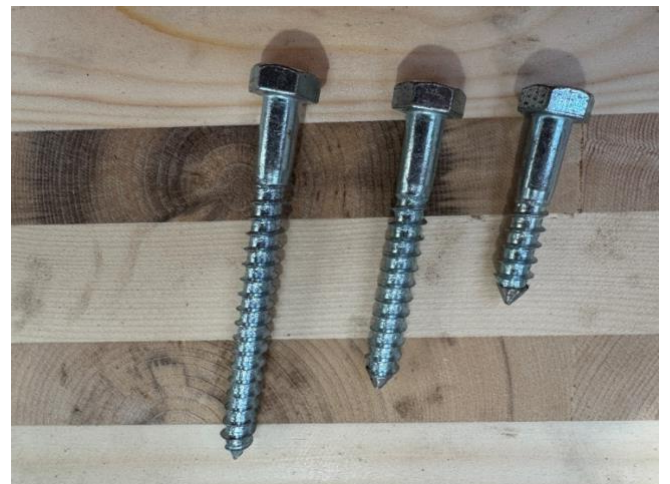
They are made of non-hardened steel and are characterised by having a coarse thread, hexagonal bolt head, and for all but the smallest sizes (M6 and below) require the drilling of a pilot hole. Photographs of the ones used in this study are shown in Figure 26. For the purposes of testing, where shorter samples were required, they were cut to size and sharpened as shown so the amount exposed to flame remain constant.

Figure 26 Hex Coach Screws

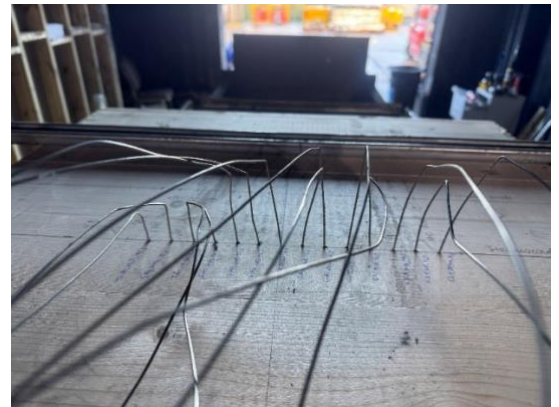
To support a better understanding of the thermal response of the CLT itself to fire the instrumentation was initially configured to assign all thermocouple resource to the detailed analysis of heat conduction into the timber at 10mm intervals in the same horizontal linear position that the fixings would be mounted in. This test was conducted once the repeatability of the fire challenge had been confirmed so the results could be considered appropriate to all test conducted under the same conditions.

Figure 28 Position of thermocouples within the CLT for detailed thermal analysis

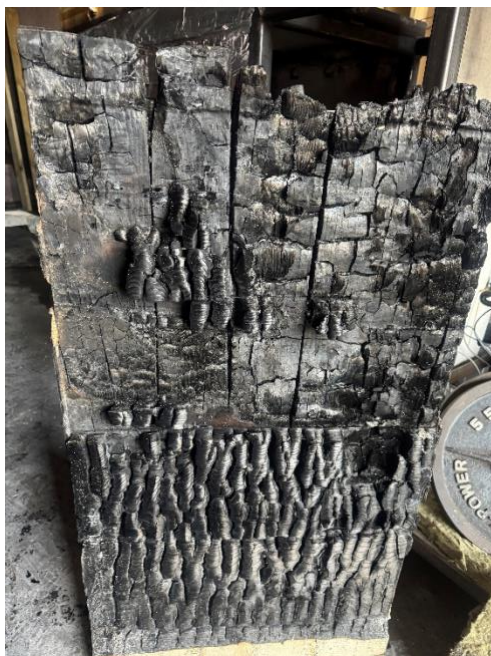
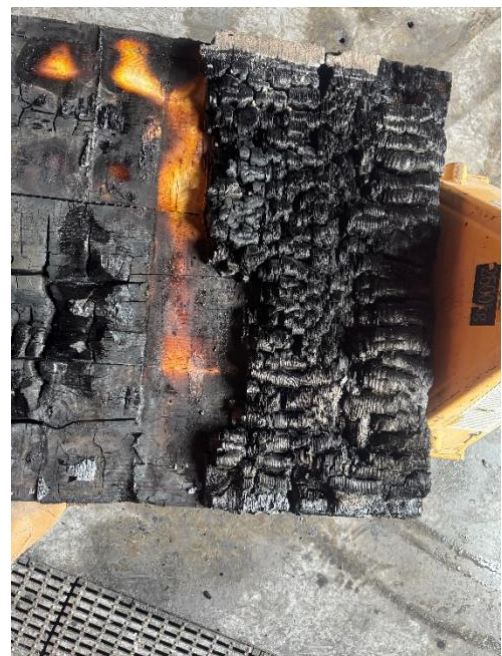
Figure 29 Wall and Ceiling samples post-test with some char cleared for measurement

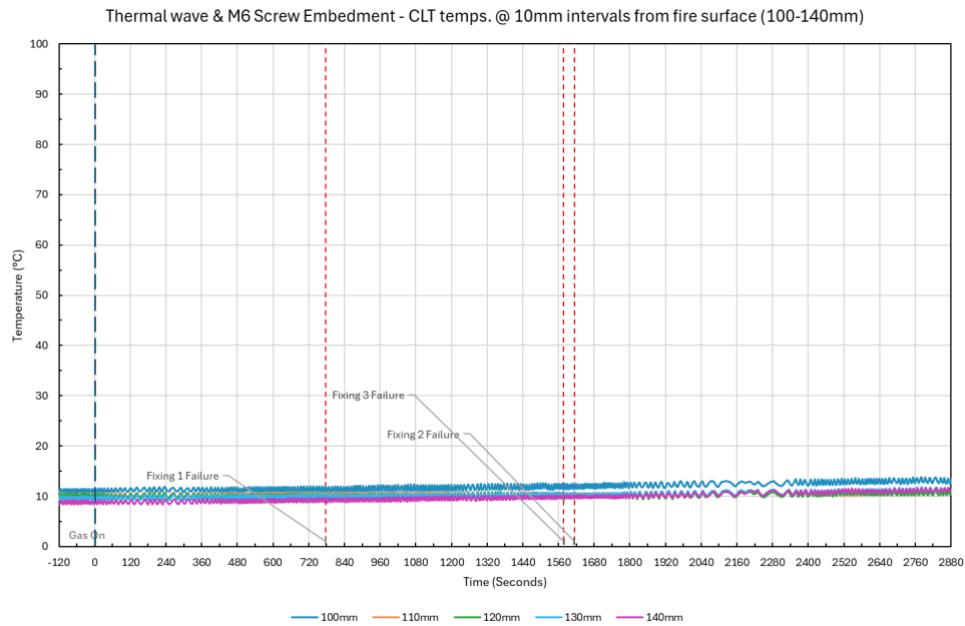
Figure 32 Temperature profile within CLT for thermocouples mounted between 100mm and 140mm from the original ceiling surface

- The pause in heating at 100°C from moisture being driven from the timber is very apparent
- Within the time period of 1 hour the 100°C threshold is never reached for depths greater than 50mm
- Above 100mm depth there is no measurable change in the temperature of the CLT meaning that at this time the original hold capability of any part of a fitting at this depth would be unaltered subject to there being no conduction of heat down the fitting.

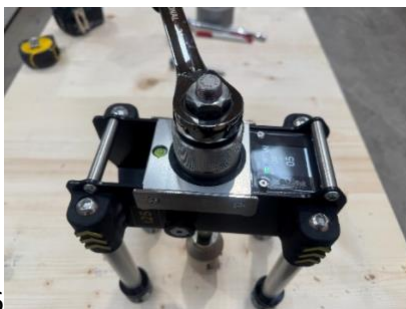
As a benchmark, the load retaining capability of all tested fixings and configurations, was appraised using an industry standard pull-out tester hired for the purposes of this study. The device provides for a stable attachment to the surface, a means of gripping the fixing head and applying force, and a load cell to measure that force. The device records the maximum value attained before the load drops following failure and dislodgment.

6  
Figure 33 Load pull out equipment

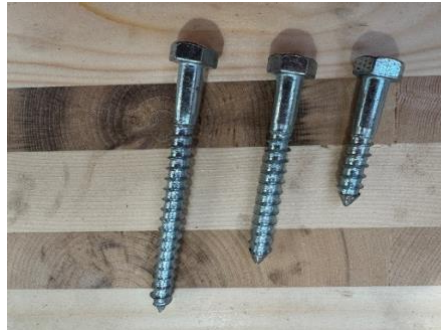
The impact of embedment depth was assessed using 100mm M12 Hex Coach screws cut down to size to give the same amount of protrusion (10mm) below the CLT ceiling. This is necessary to ensure that the results are not influenced by any differences in heat collection from the flame zone resulting from different protrusion lengths.

Figure 35 M12 embedment test Hex Coach Screw fixings

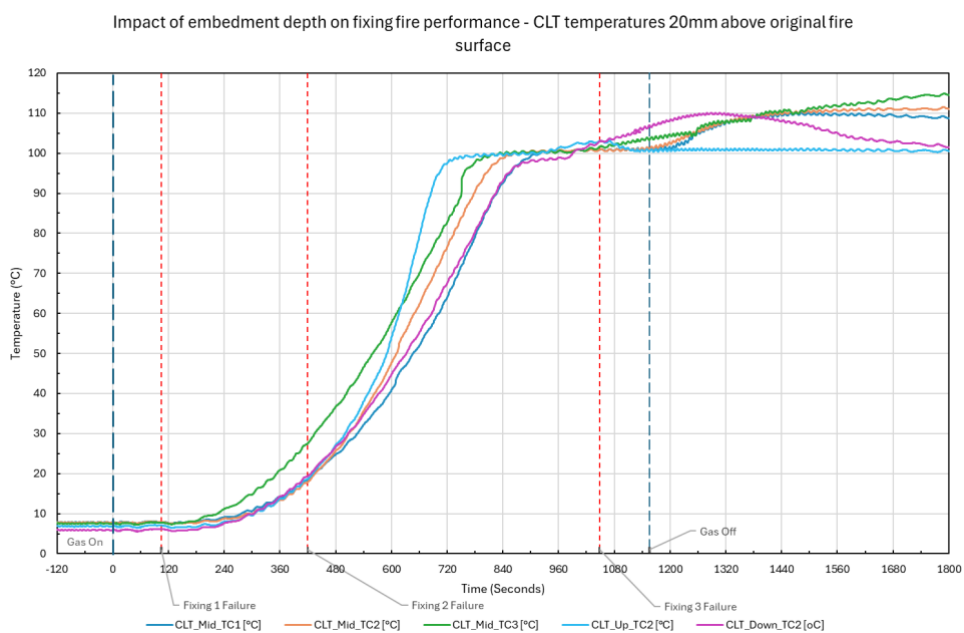
A clear relationship is shown of increasing retention capability with embedment depth but in every case:

- The fixing fails when restraining only a fraction of its non-fire measured capacity
- CLT temperatures are low or unchanged at the time of fail suggesting that timber heating that leads to loss of strength is occurring local to the fixing and its threads

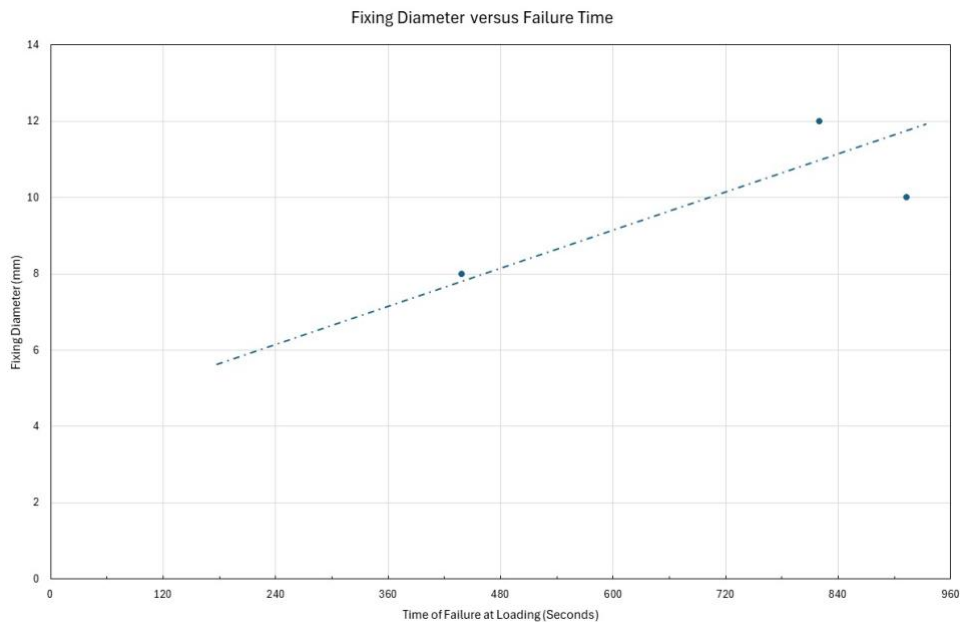
A clear relationship is difficult to discern because the smallest diameter fixing failed through a different mechanism to the other two, melting as opposed to pull-out (an important finding). That said, again all fixings failed whilst supporting only 1/10<sup>th</sup> of their ambient (non-fire) load bearing capacity. At the time when the two larger diameter fixings failed timber temperature along their length would have ranged from 250°C at their insertion point, to ambient at their tips (see Figure 30). The impact of conduction down the shank of these bolts is explored later.

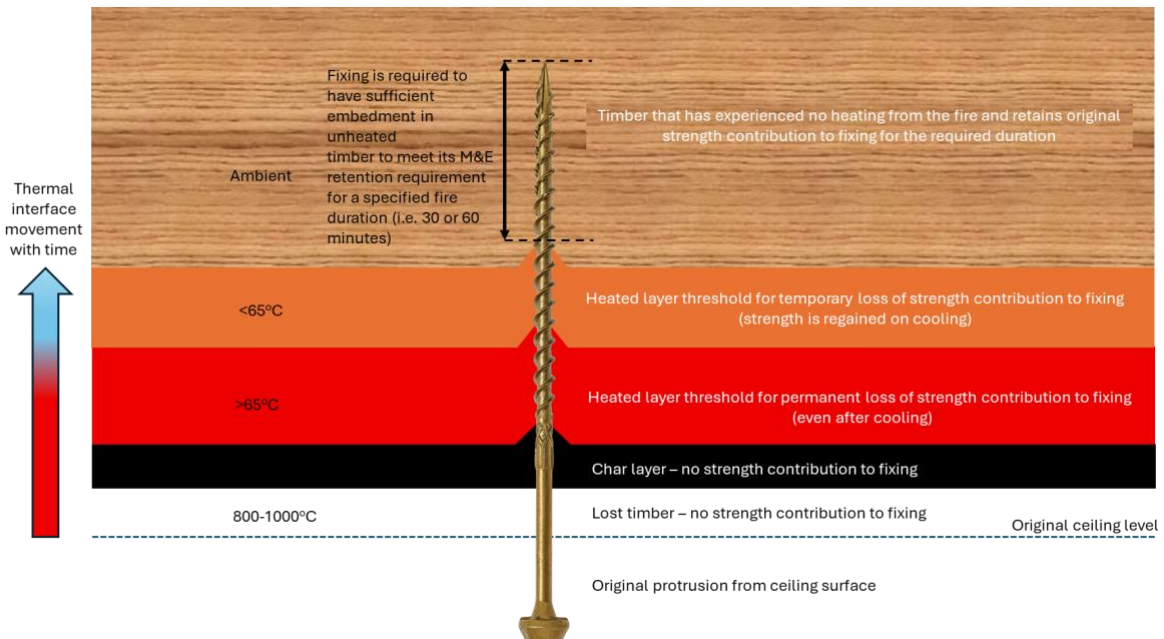
In this model, the geometry of the fixing is less capable of conducting heat deep within the wood and the increased length ensures that the thread necessary for full retention remains in unheated wood for the duration that it must remain effective.
